March 3, 2006
Job No. 2441.401A

Subject: Slope Inclinometer Monitoring
Kelok Way
Clayton, California

EXECUTIVE SUMMARY

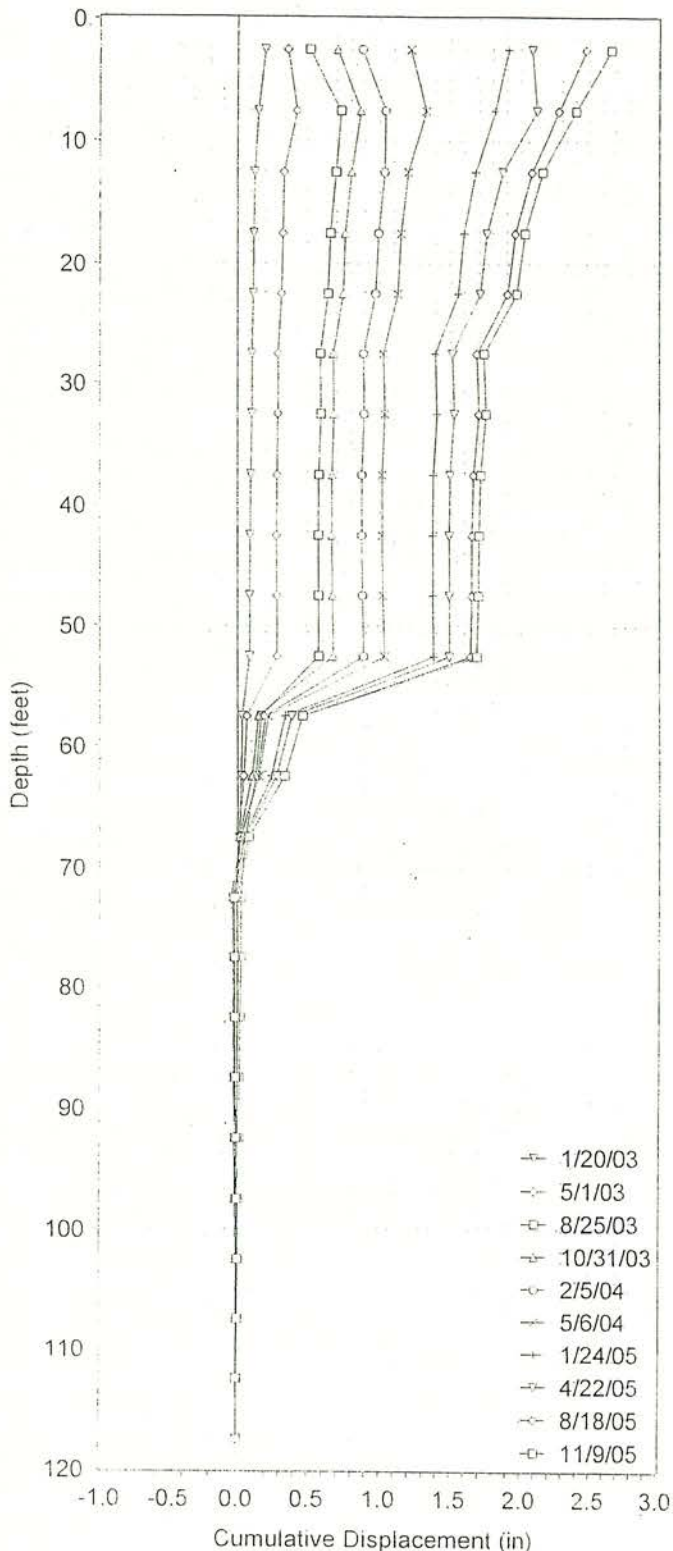
B-1, A-Axis

2. Slope inclinometer B-1 has shown continuous slide movement at a depth of about 60 feet since our first follow-up reading on May 1, 2003.
3. Slope inclinometer B-1 has experienced about 1.7 inches of offset at a depth of about 60 feet between January 2003 and November 2005.

4. Slope inclinometer B-1 has experienced an additional 1 inch of movement at a depth of about 28 feet between January 2003 and November 2005.
5. The total bottom to top horizontal movement in Slope Inclinometer B-1 has been 2.7 inches between since January 2003.
6. We judge it likely that at least several homes on Kelok are being impacted by this movement. It is at least a possibility if not a probability that more homes will be impacted if this movement continues.
7. The asphalt cracking in Kelok Way that has developed over the past 2 years is likely associated with this slide movement. If so, then the traveled roadway and underground utilities in Kelok Way are also being affected by this slide movement; this is likely to result in leaks in the wet underground utilities.
