Re: Summary of Geotechnical Monitoring and Inspection Services on June 30, 2016  
Inclinometers/Piezometers/Wells at Kelok Way, Clayton, California  
*SFB Project No: 555-2*

**KELOK WAY MONITORING LOCATION MAP**

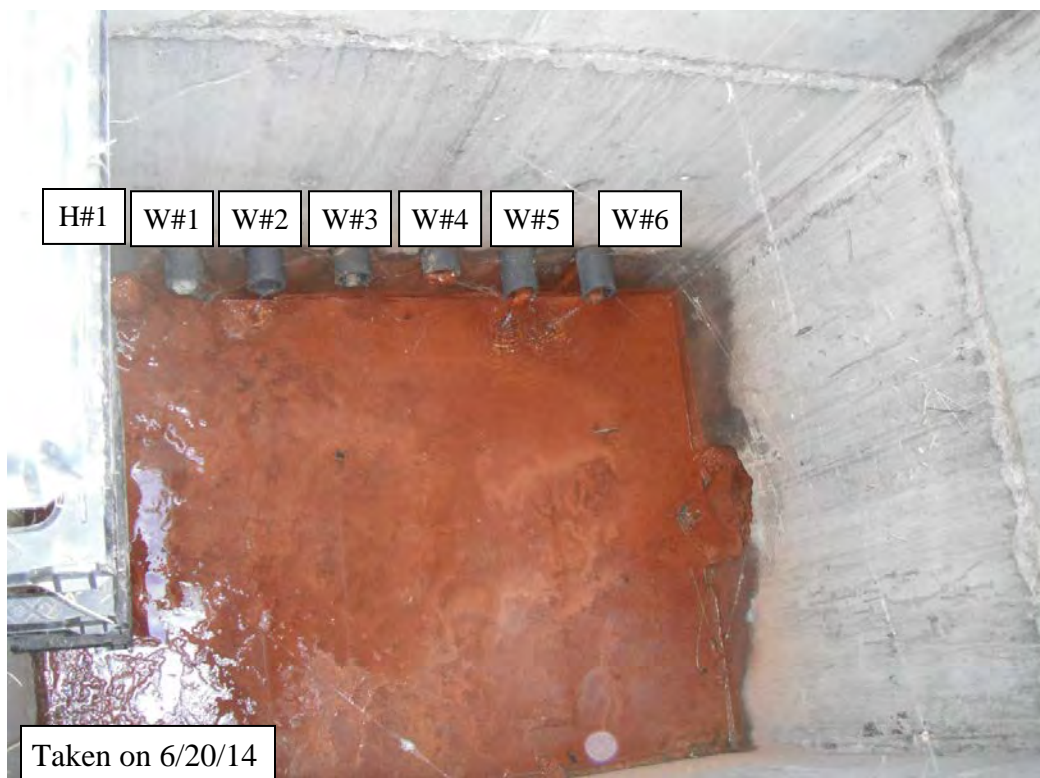
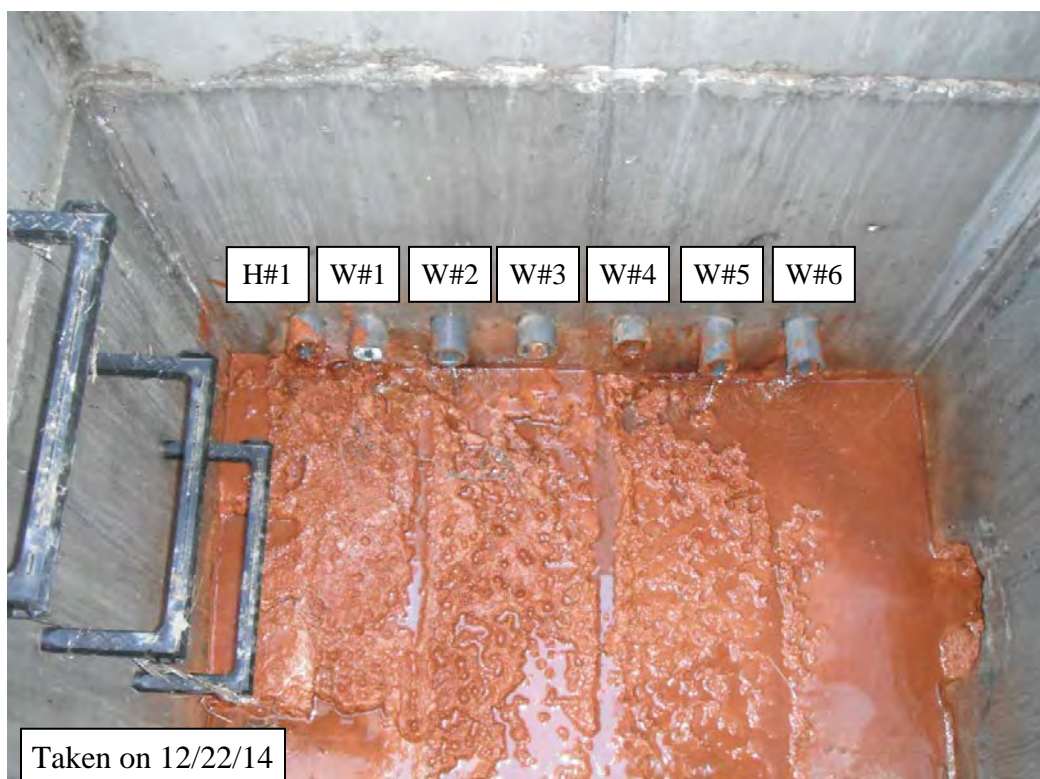
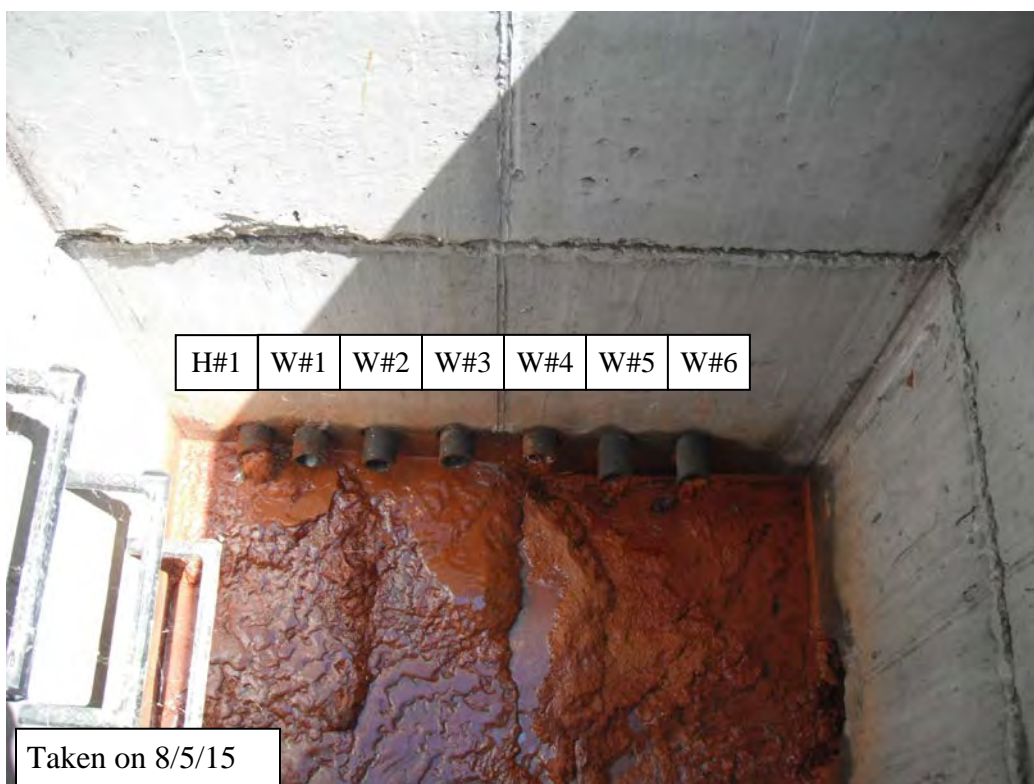
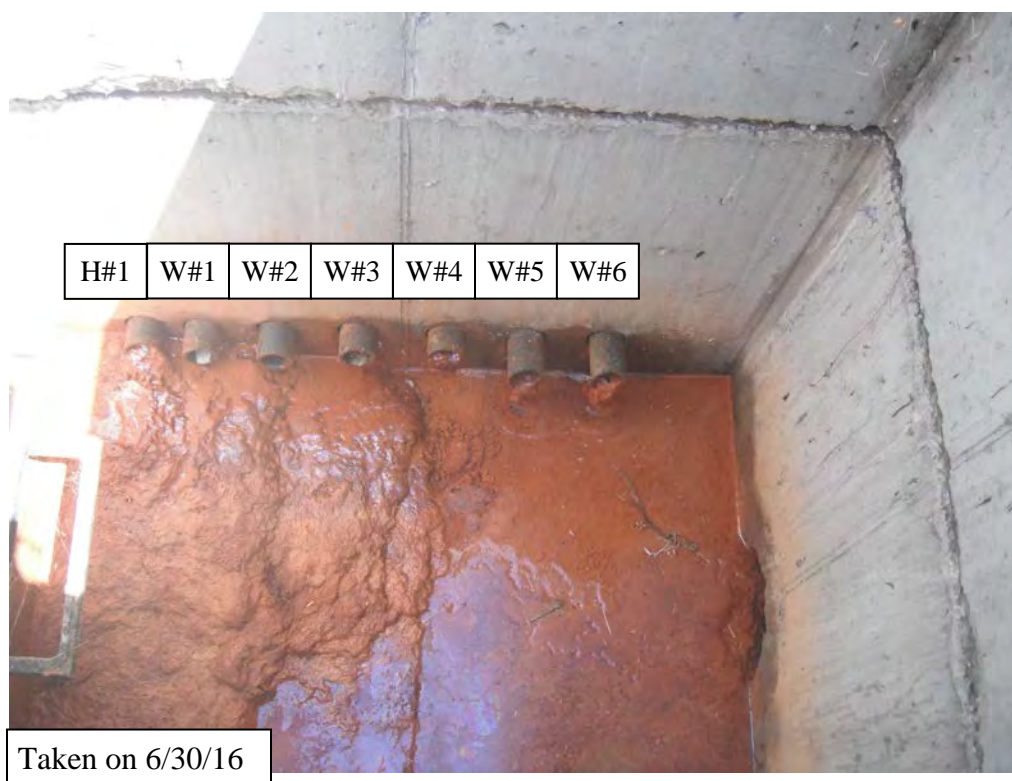
**Figure 2, Photograph of Outlet Pipes**

Discharge from the dewatering well outlet pipes in the collector box was observed on June 30, 2016, with Drains H#1, W#2, W#5, and W#6 exhibiting a stream of water, Drains W#1, W#3, and W#4 showing dripping water. Drain H#1 is an outlet pipe that was encountered at the approximate collector box location during the construction of the collector box in the fall of 2012; it is unclear what H#1 drains. Field photographs of these outlet pipes taken on 6/20/14, 12/22/14, 8/5/15, and 6/30/16 are attached as Figure 2 for reference.

The results of our vibrating wire and open pipe piezometer monitoring generally showed similar results as those indicated by historical monitoring records. The measured groundwater levels in the piezometers generally indicated about the same groundwater level conditions on 6/30/16 compared to the previous monitoring results on 8/5/15. The discharge conditions of dewatering well outlet pipes are similar to what was observed at the completion of the wells.

We recommend outlet pipes in the collector box shown on Figure 1 be hand cleared of any built up debris or deposits. We recommend this removal occur on a yearly basis. To increase the water discharge from Wells W#1, W#3, and W#4, consideration should be given to installing sump pumps directly into the wells located within Kelok Way and discharging the pumped water to the existing storm drain system. Dewatering the wells may increase the stability of the hillside.

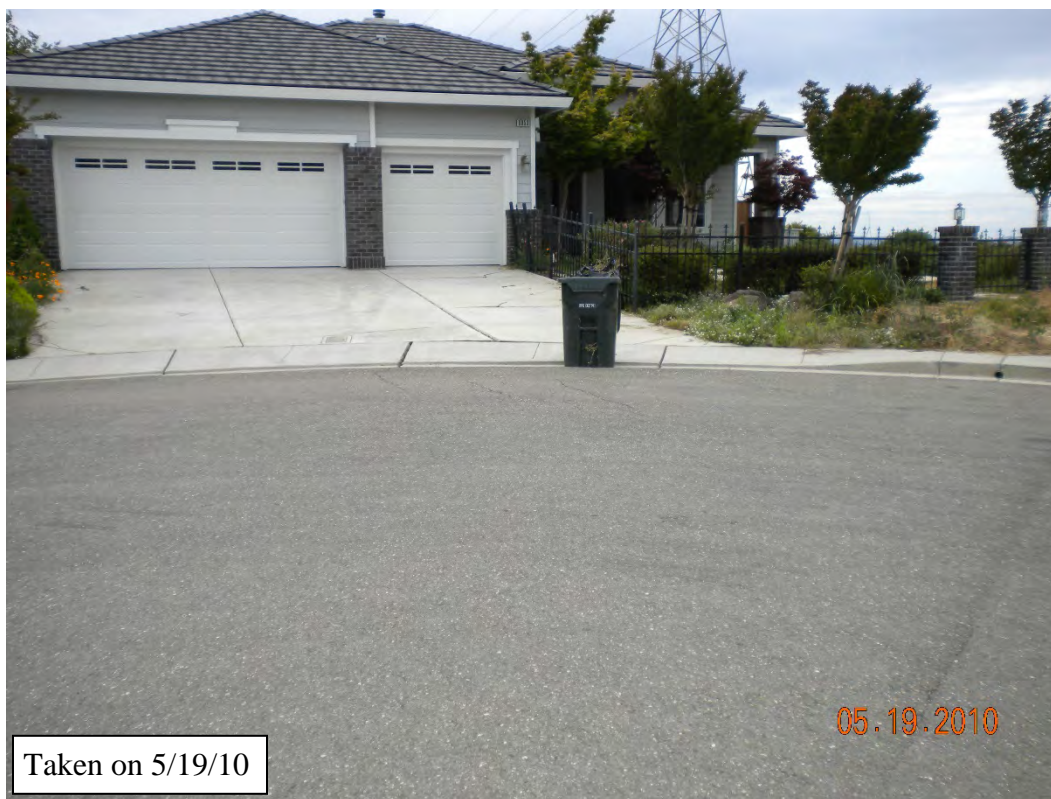
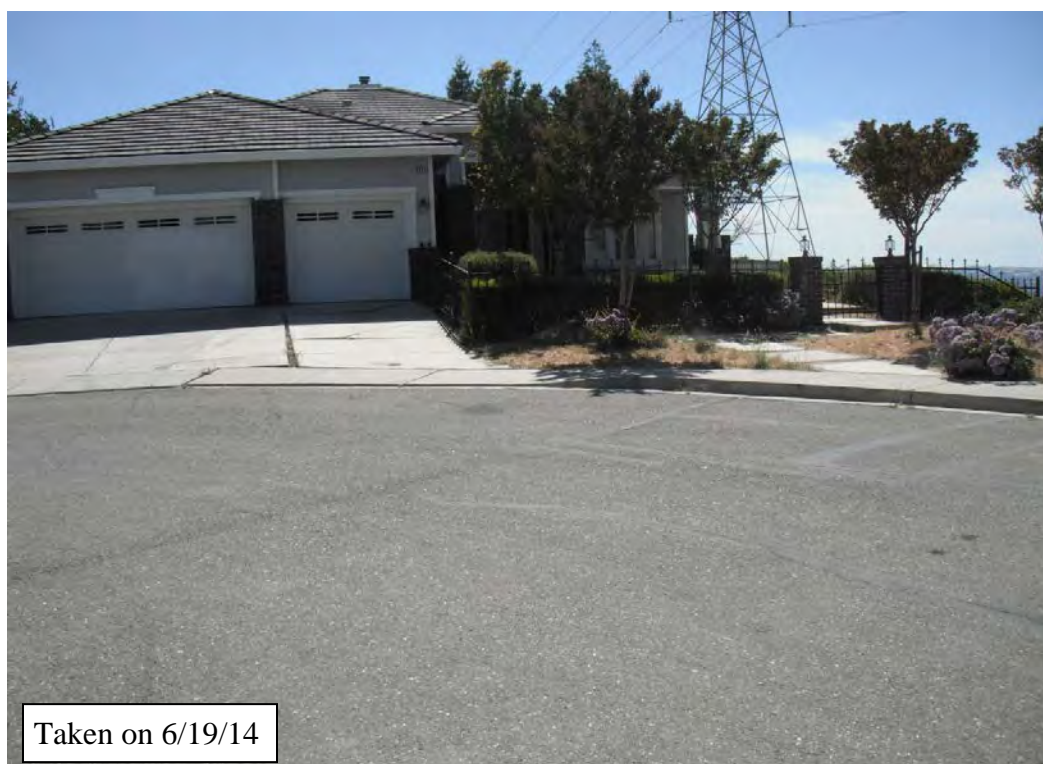
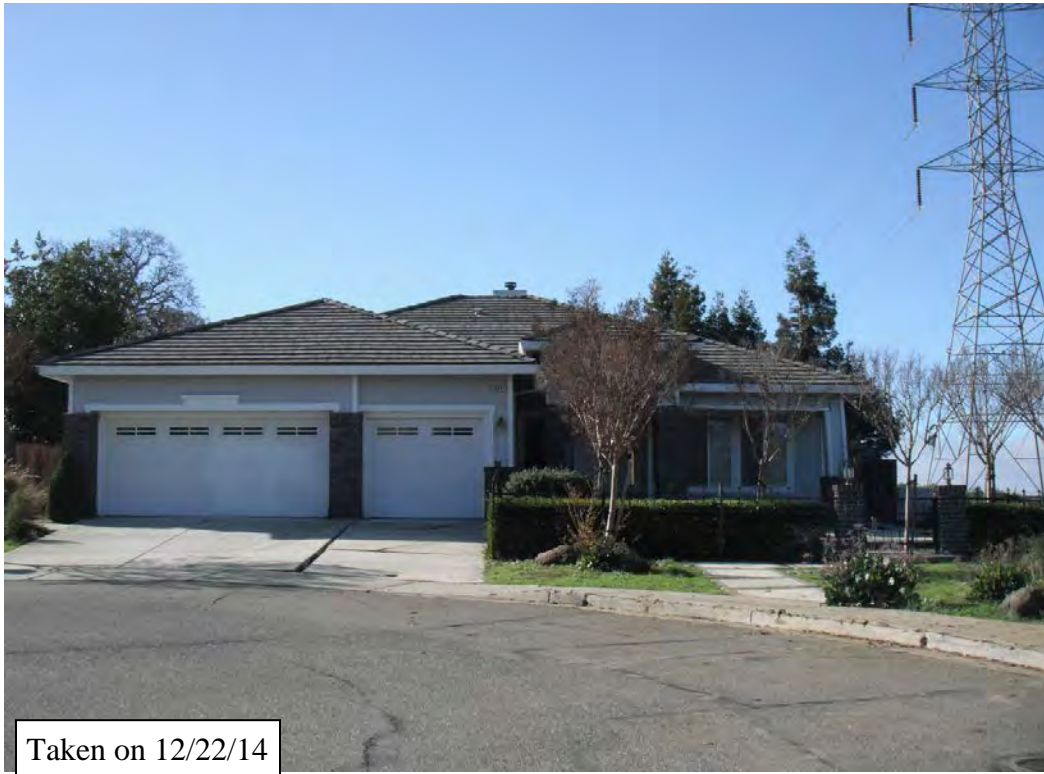
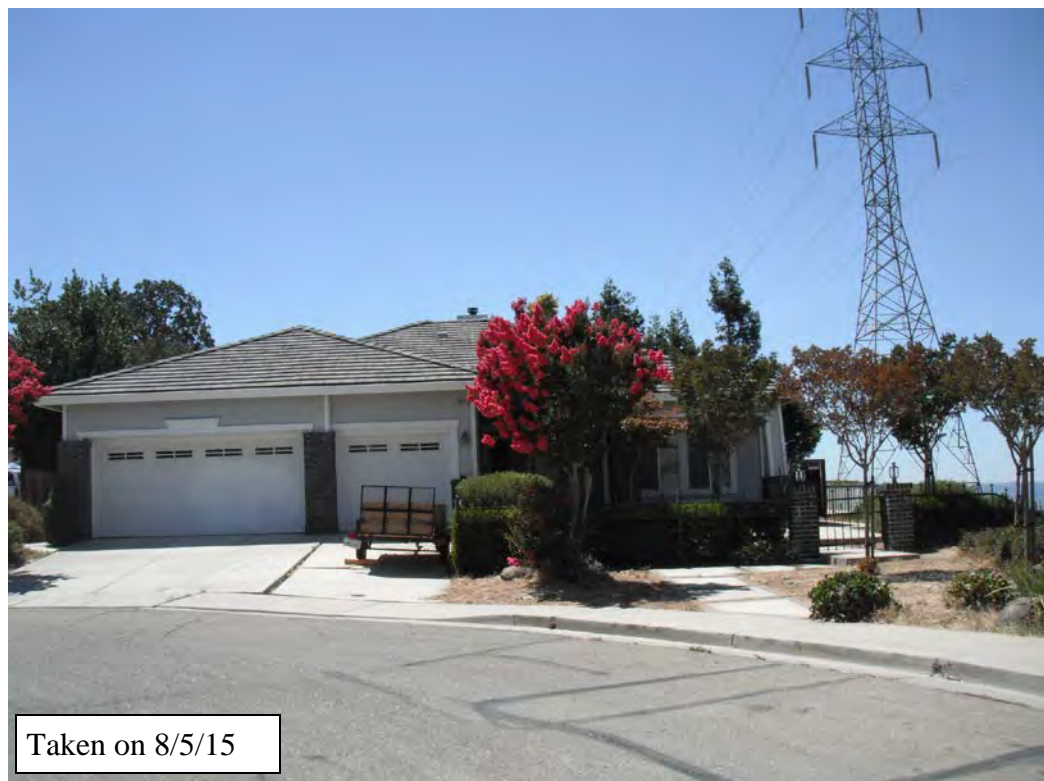
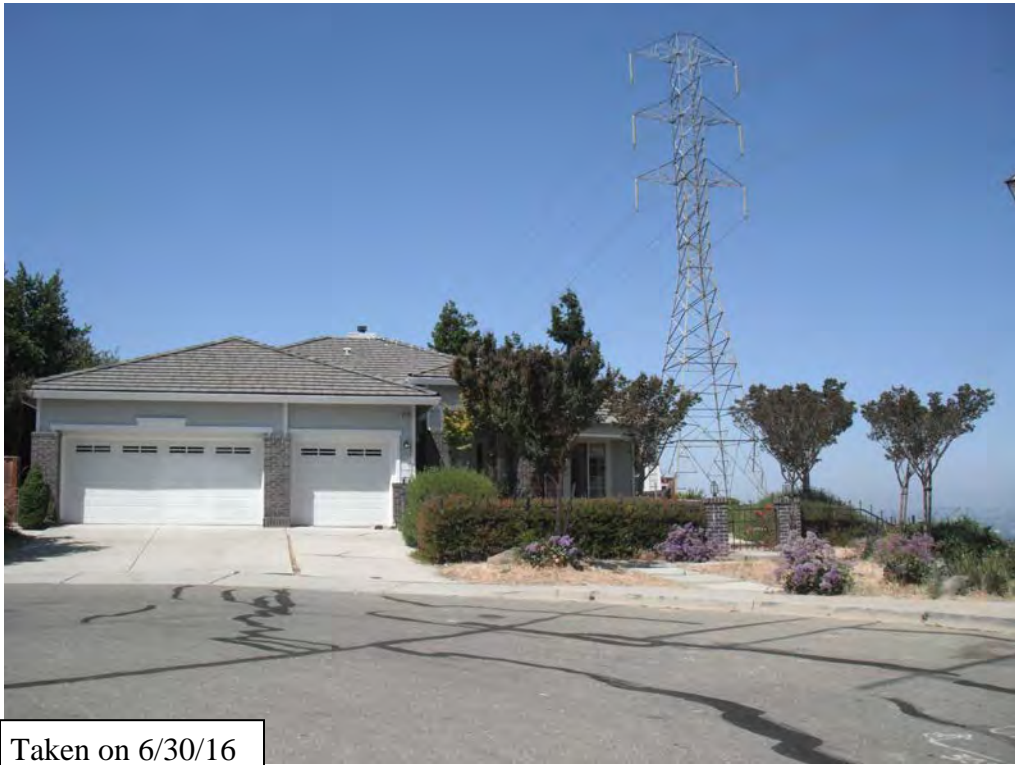
**Figure 3, 8053 Kelok Way**

The past slope movement in the area of CSA SI-4 has caused movement of the Kelok Way cul-de-sac, associated infrastructure, and the home and improvements at 8053 Kelok Way. The home at 8053 Kelok Way has clearly undergone detrimental movement that affects the structural integrity of the house. At the time of our 6/30/16 field reconnaissance, the house appeared to be unoccupied. Future slope movement will result in significant and detrimental damage to the public and private property and associated improvements located upslope and downslope of CSA SI-4 shown on Figure 1. The magnitude of damage and when the damage will occur cannot be accurately predicted due to numerous variables. We recommend a replacement inclinometer casing be installed in the area for further monitoring. Serious consideration should be given to stabilizing the movement and repairing the damage. We also recommend the existing infrastructure (including underground utilities) be inspected to determine if detrimental damage has occurred. Any damage to water bearing utilities should be repaired immediately to reduce

the potential for subsurface water breaks that could decrease the stability of the slope and potentially cause slope failure.

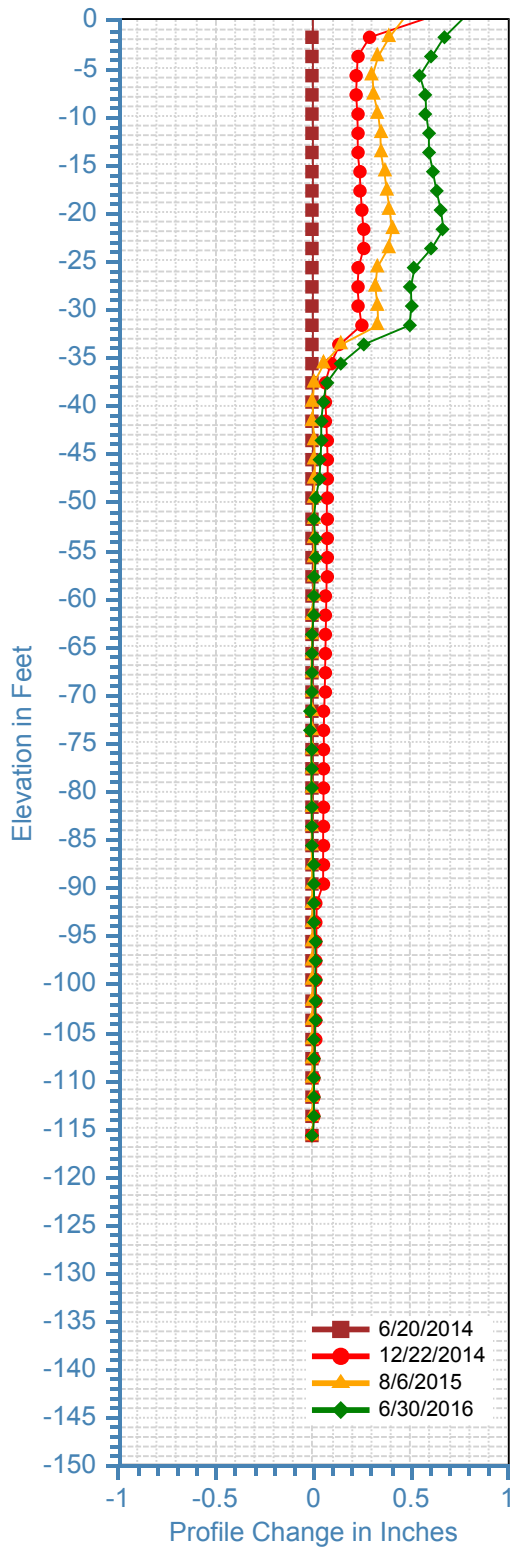
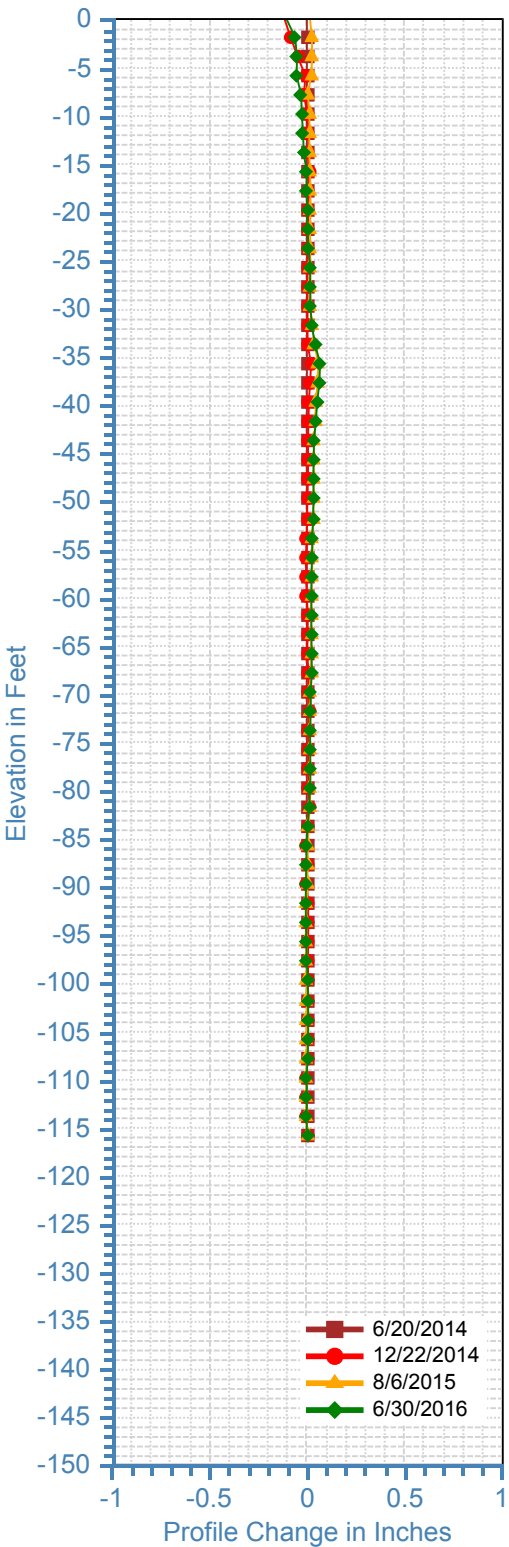
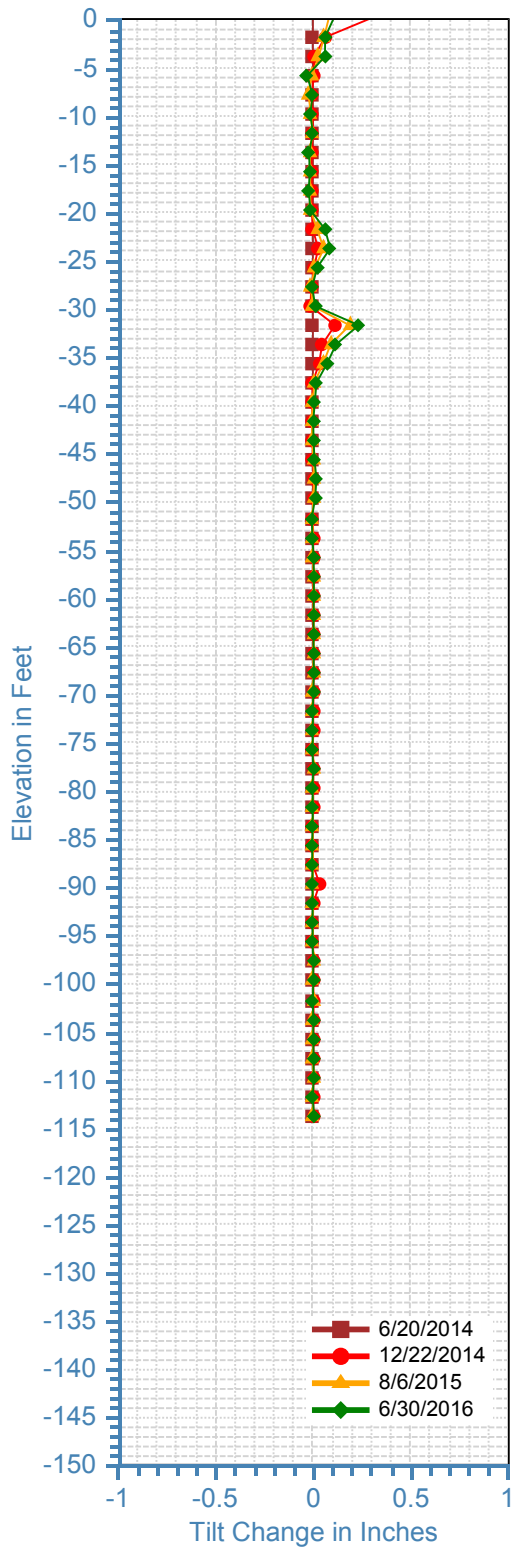
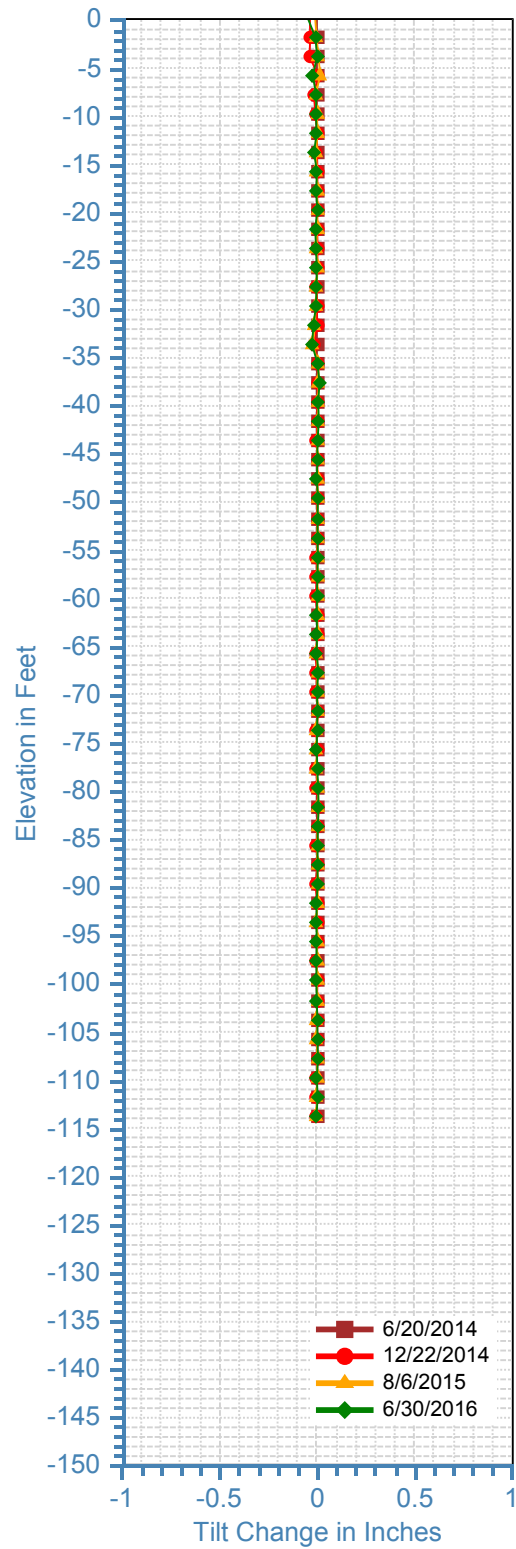
555-2 BGC SI-1, A-Axis

By comparing to the initial readings on 6/19/14 and 6/20/14, Inclinometer Casings CSA SI-3 and W SI-1 generally do not indicate obvious horizontal movements. Inclinometer Casing CSA SI-1, appear to indicate on-going fill expansion with cumulative displacement (profile change) of about 1.6 inches at ground surface since 6/20/14. The movement at Inclinometer Casing BGC SI-1 indicates both on-going fill expansion and slope creep with cumulative displacement of about 0.8 inch since 6/20/14. Inclinometer Casings CEG SI-1, CSA SI-2, and W SI-5, indicate very slight horizontal movement (0.1 to 0.2 inch) at depths of 88, 111, and 96 feet, respectively, since the initial readings were taken. These movements are probably related to the very slow creep along the existing buried deep-seated old slide plane in the area.
