July 22, 2016
Job No. 2947.102

Subject: Slope Inclinometer Monitoring Program
Open Space Slope Below Lots 59 through 61
Pebble Beach Drive
Clayton, California

SITE PLAN V-DITCH OBSERVATIONS

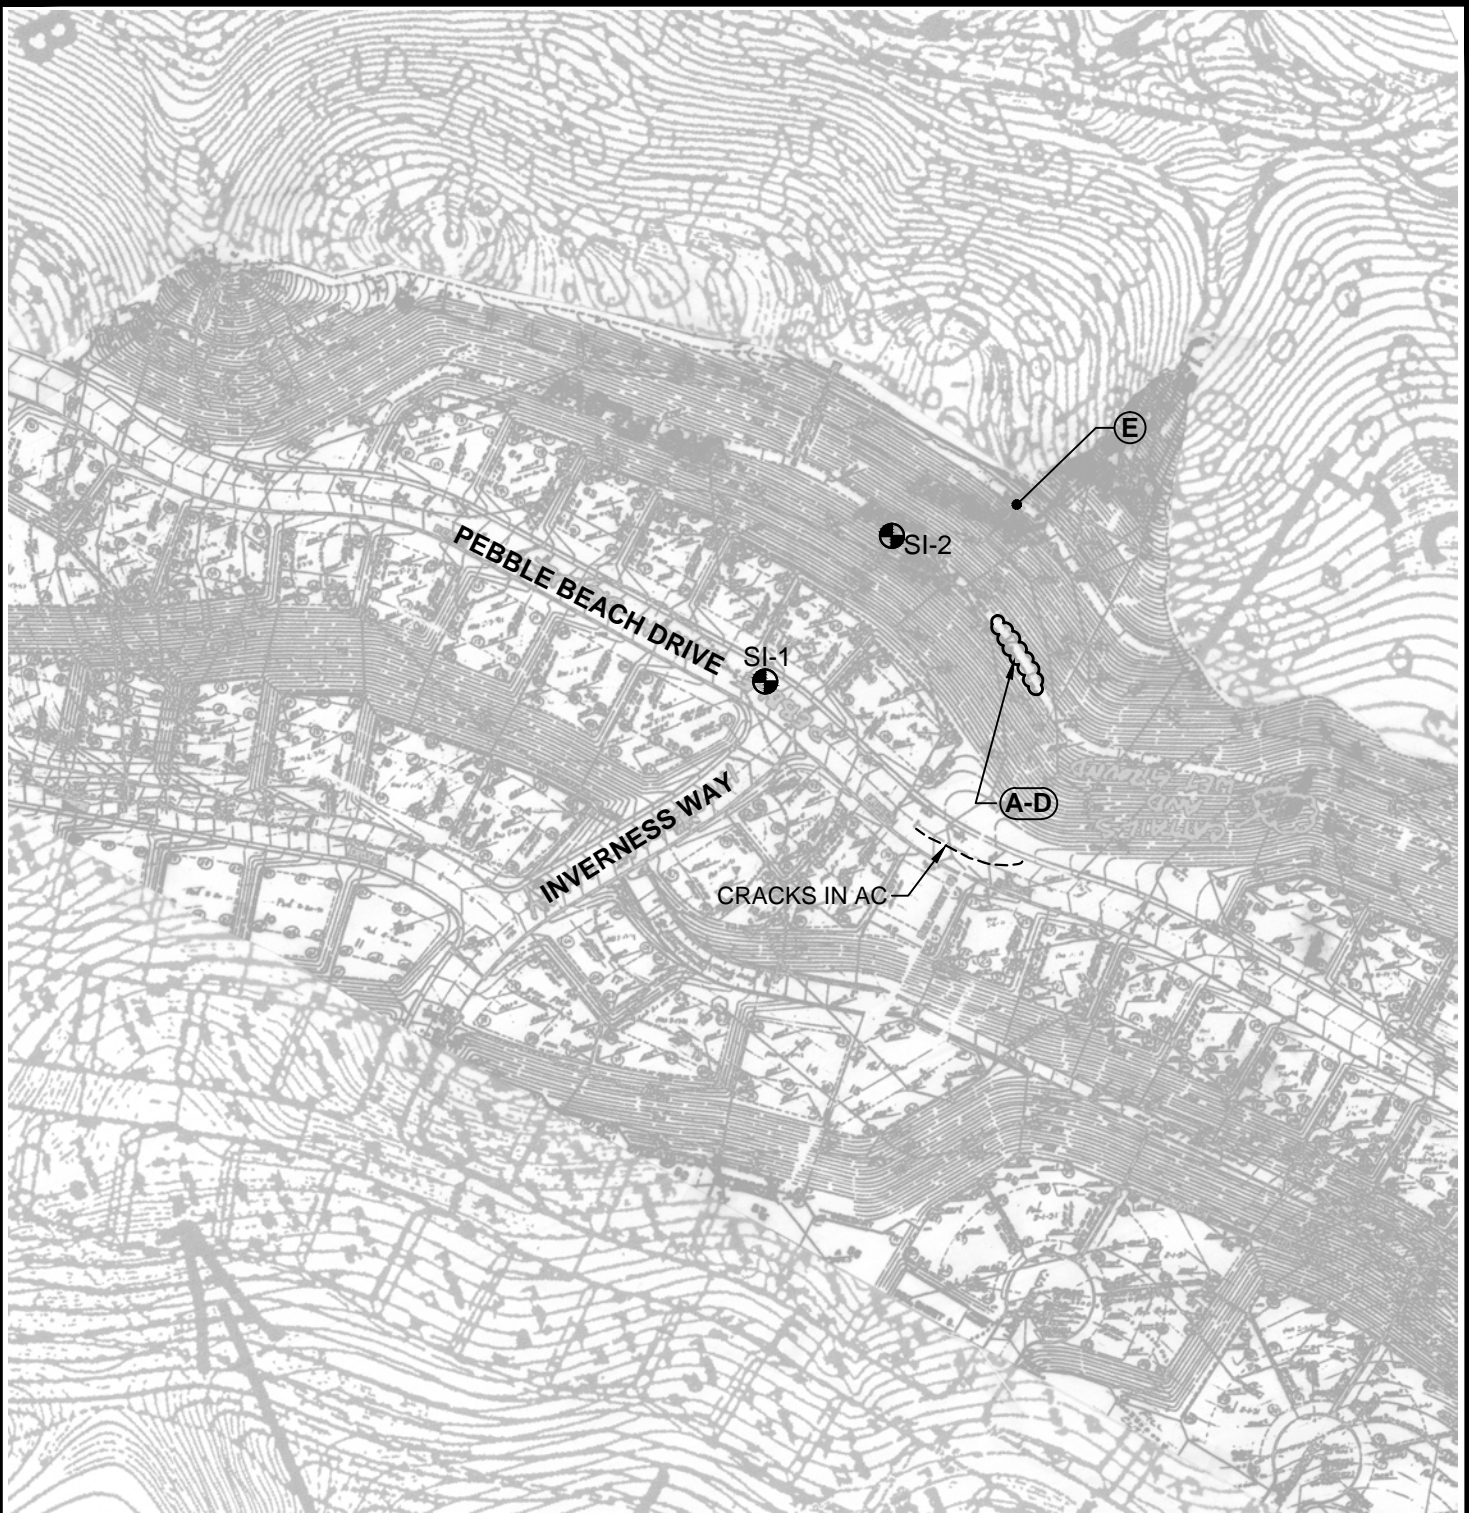
The V-ditches below Pebble Beach Drive were walked in the field. Observations by our engineer indicate that no significant movement has occurred in the v-ditches since our last field exploration in 2014. Cracks A, B, C and E have been patched since our last observation. Crack D has not been patched. For a more in depth description, please see the attached Site Plan and photographs.

Note: Cracking of the AC Pavement was apparent in several locations on Pebble Beach Drive; one of these sections is presented on Plate 1, Site Plan and Appendix A, Photographs.

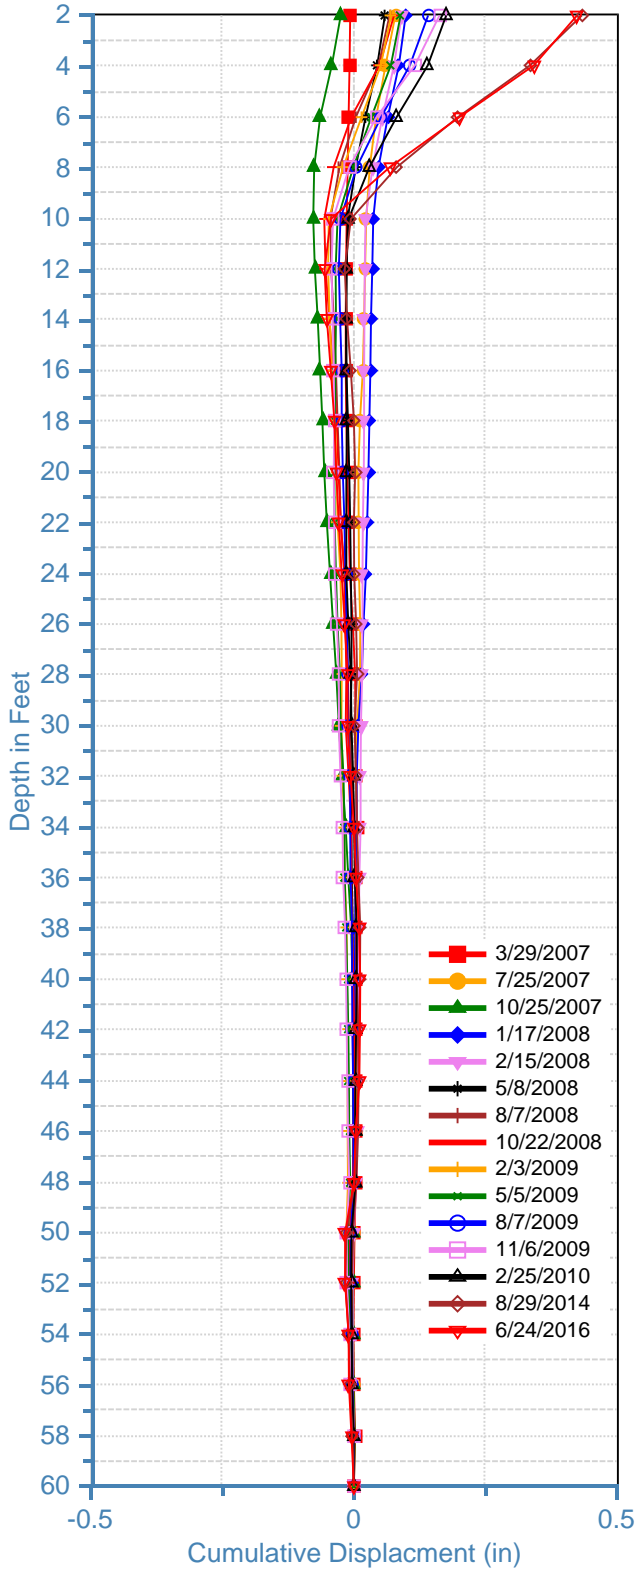
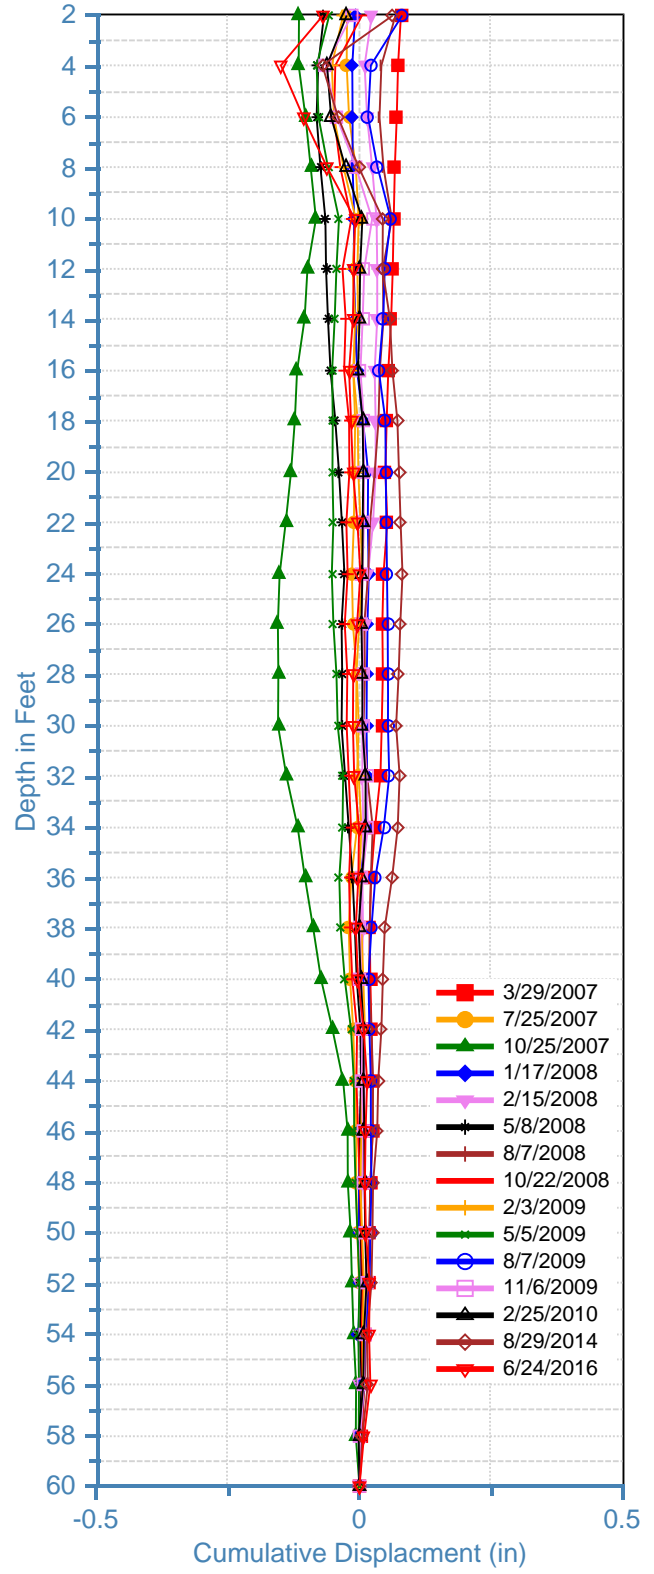
SI-1, A-Axis

| SI-1 | The plotting suggests that no significant movement has occurred since our last readings were taken in August of 2014. |

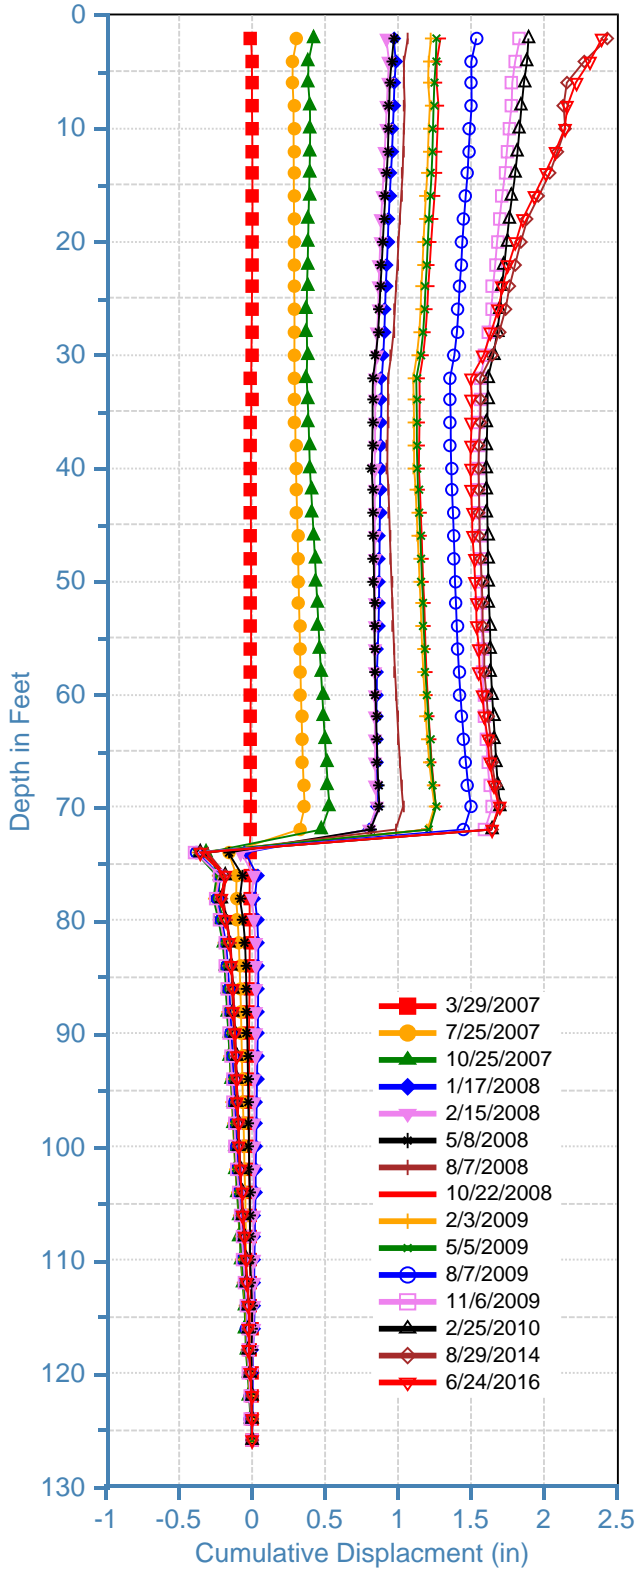
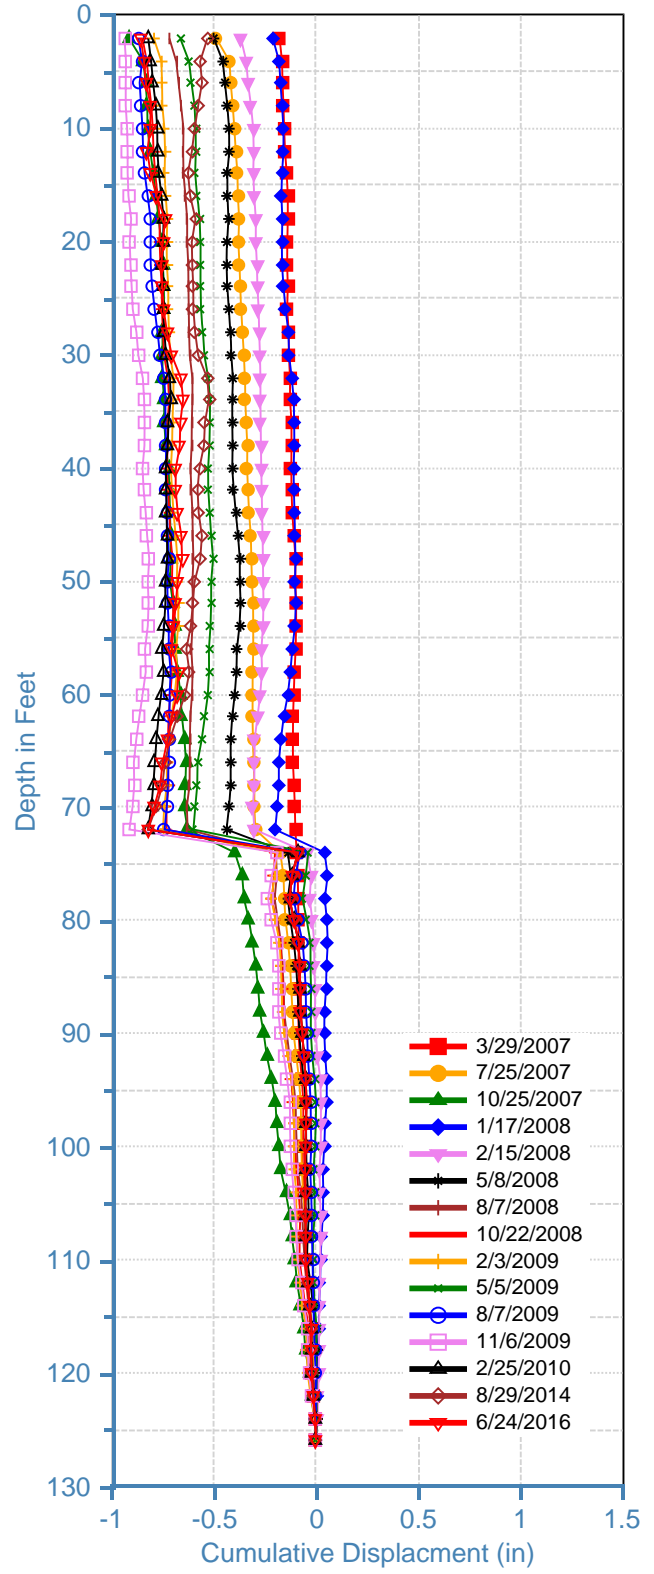
SI-2, A-Axis

| SI-2 | The inclinometer casing has pinched at a depth of 71 feet. Therefore, we were unable to take readings between 71 feet and 125 feet in depth. To process the data collected in the upper 70 feet, we used the prior readings taken February 25, 2010 for depths of 71 to 125 feet to provide a data set for plotting purposes. While the plotting suggests that the upper 70 feet has not internally moved significantly since our last readings were taken in August of 2014, it is not possible to determine if the upper 70 feet has moved differentially relative to the materials below a depth of 70 feet. |

2947.100 - Open Space Slope Below Lots 59-61
Baseline Reading Date: 2-20-07
A+=N41E B+=S49E
Reading 8-29-14 refusal at 70 feet
All subsequent readings start at 70 feet

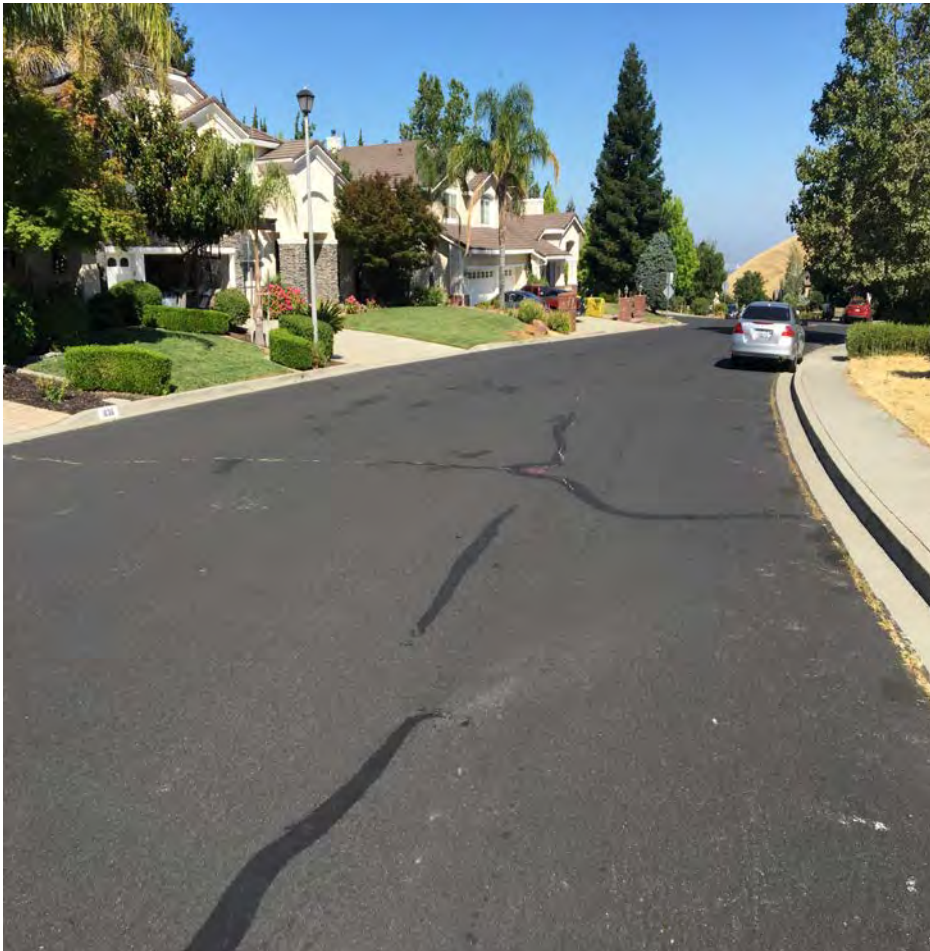
Cracks in AC pavement along Pebble Beach drive in the same location as previous observations. Viewed looking Northwest from the southeast edge of Interpreted deformation zone

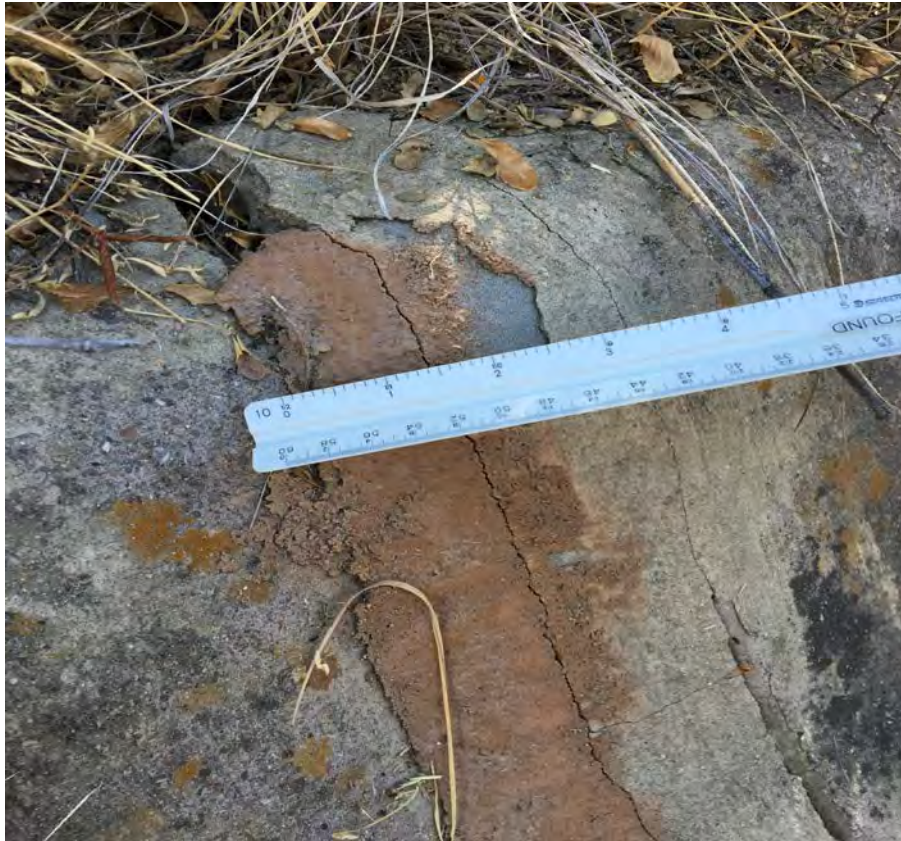
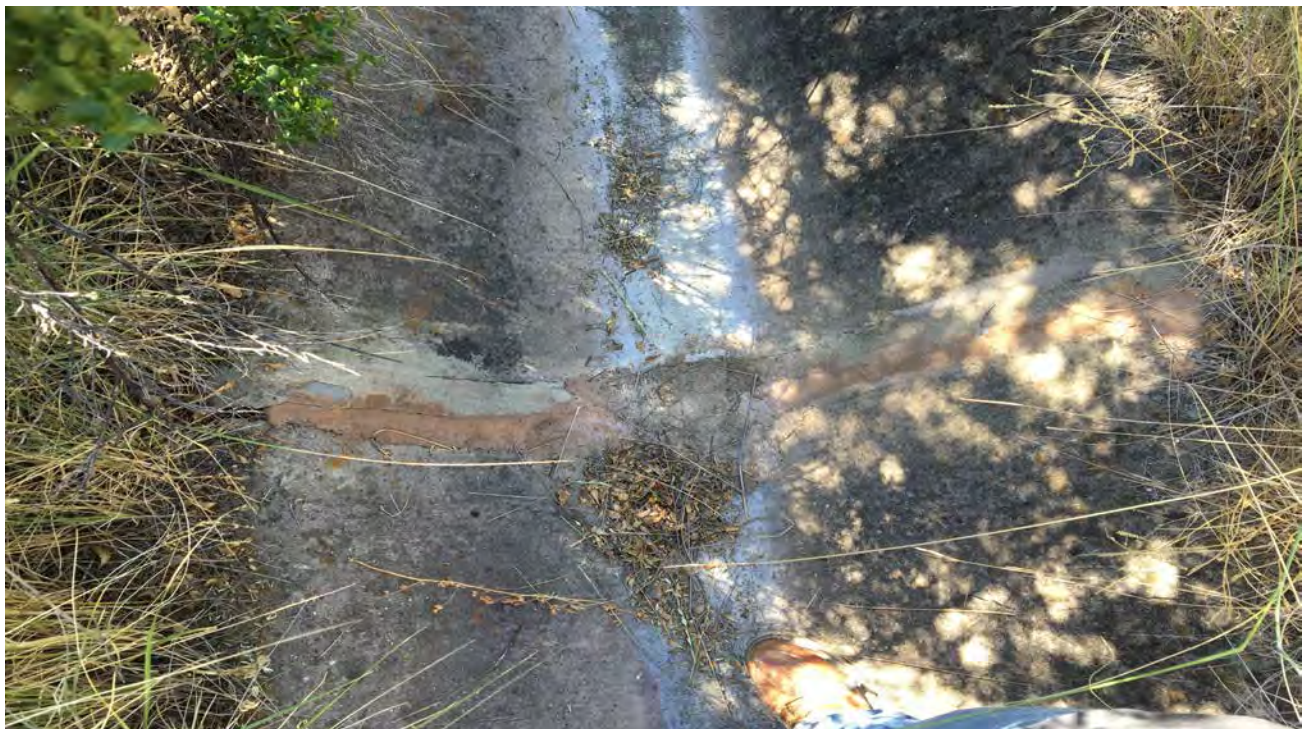
CRACK A

Crack A has been patched since our last observation in 2014. This is the most northern crack of 4 located on the mid-slope v-ditch approximately 100 feet southwest of Slope Inclinometer SI_2.

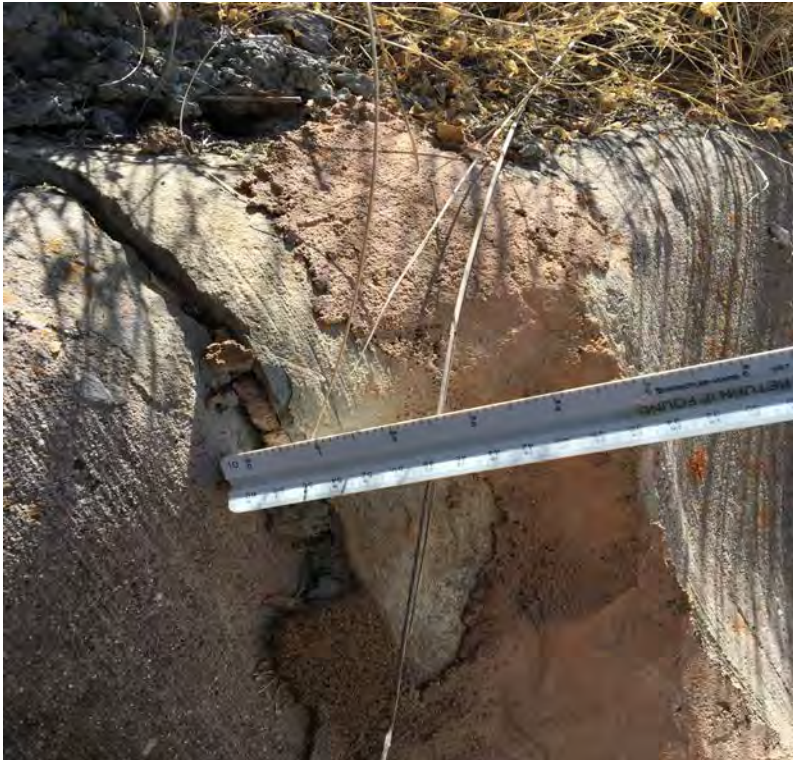
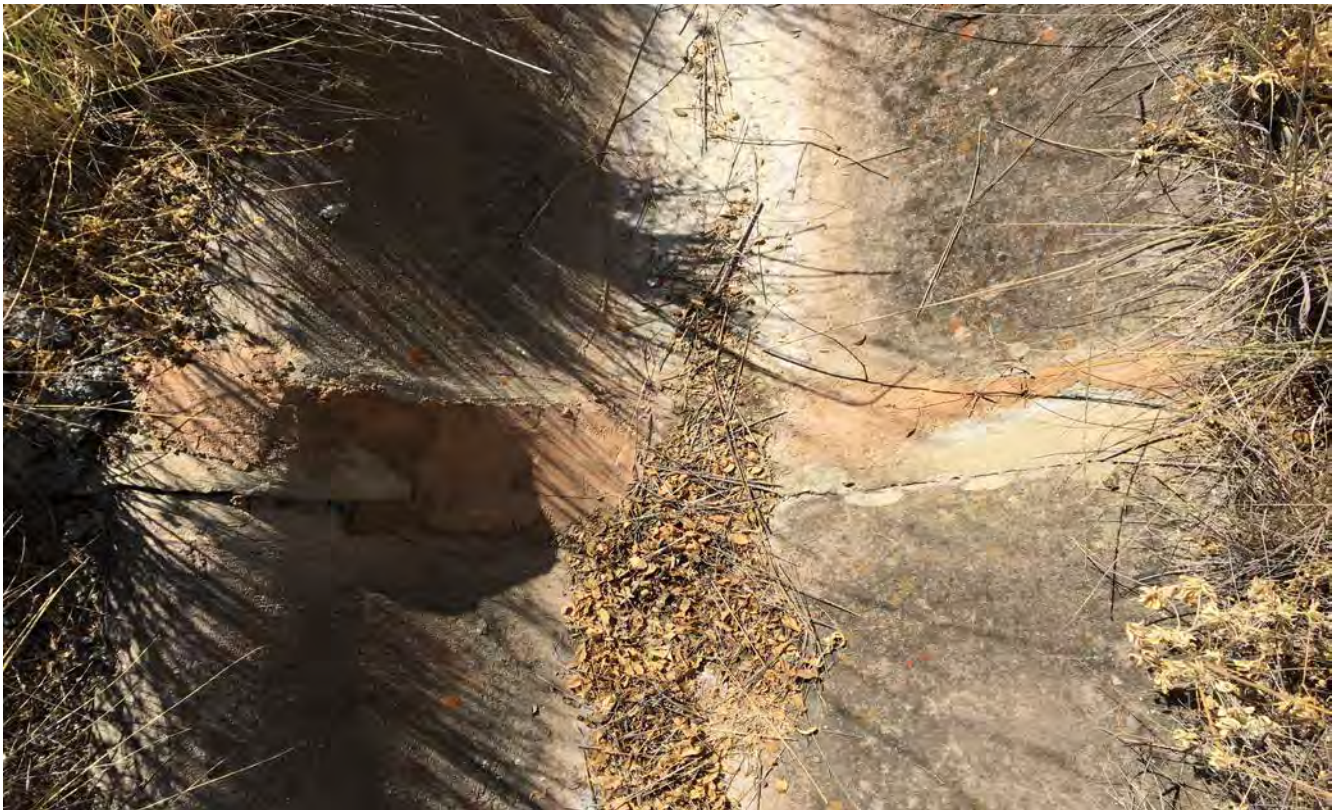
CRACK B

Crack B has been patched since our last observation in 2014. This is the second crack from the north along the mid-slope v-ditch.

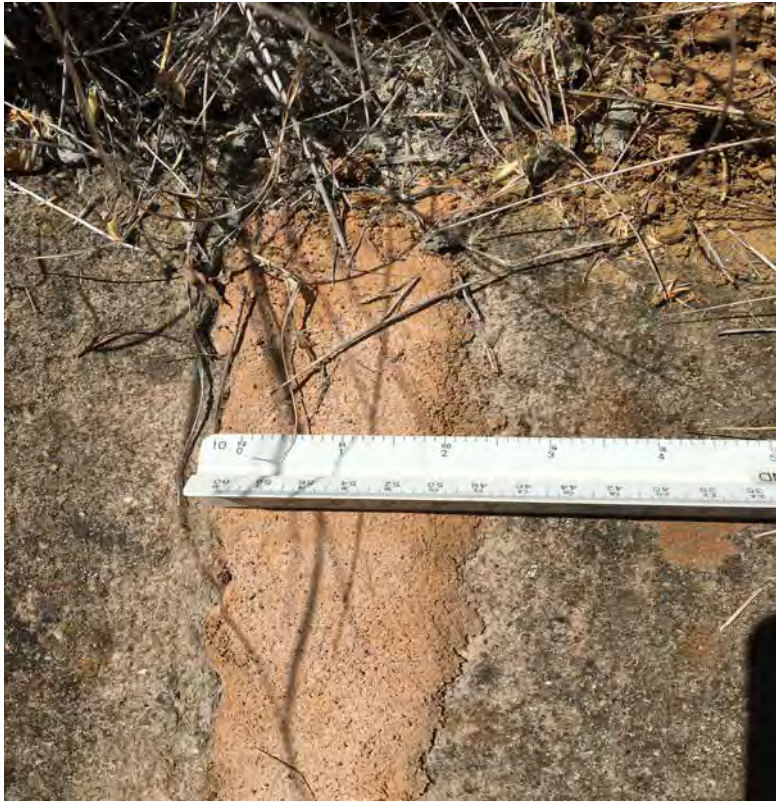
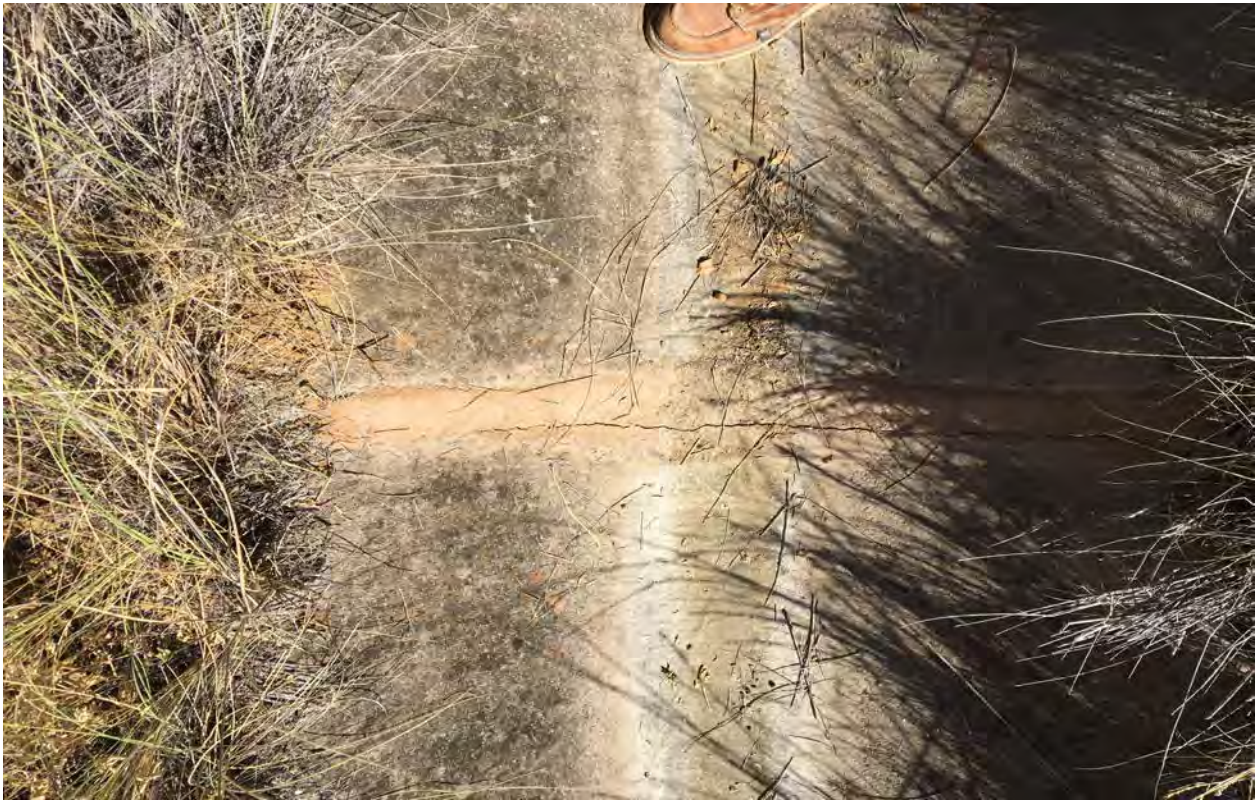
CRACK C

Crack C has been patched since our last observation in 2014. This is the opposite end of the concrete section shown in CRACK B.

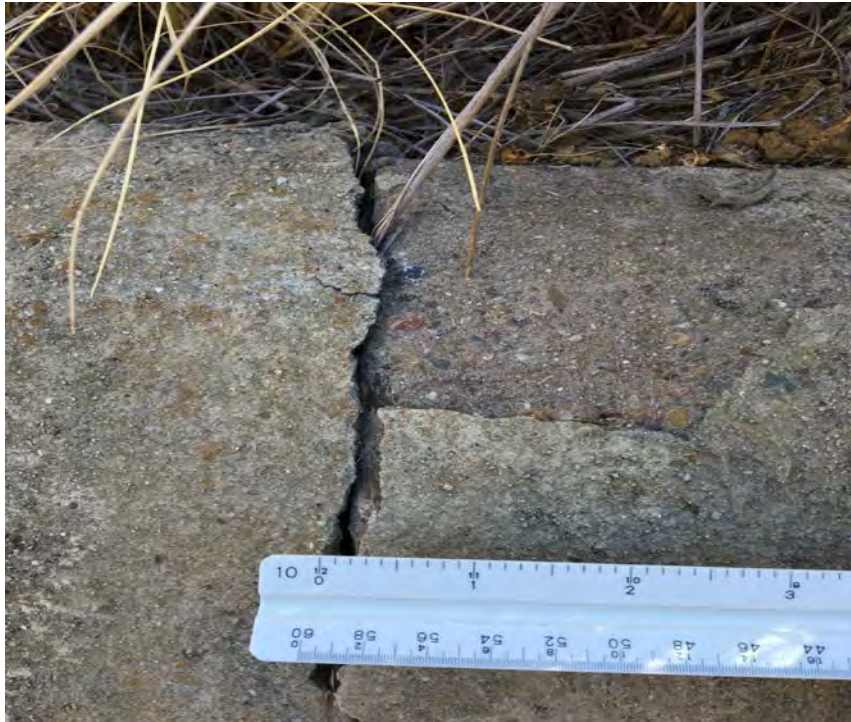
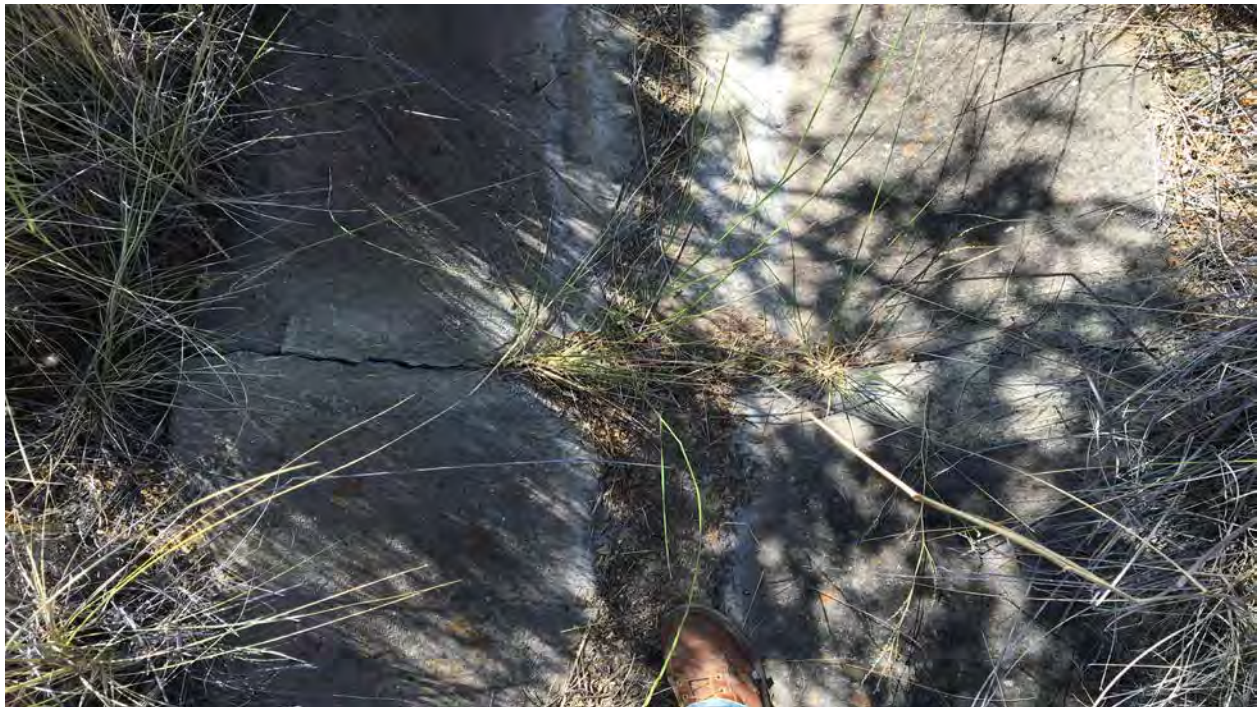
CRACK D

Crack D has not been patched since our last observation in 2014. This crack is the southernmost crack of the series of 4 located in the concrete V-ditch along the mid-slope bench.

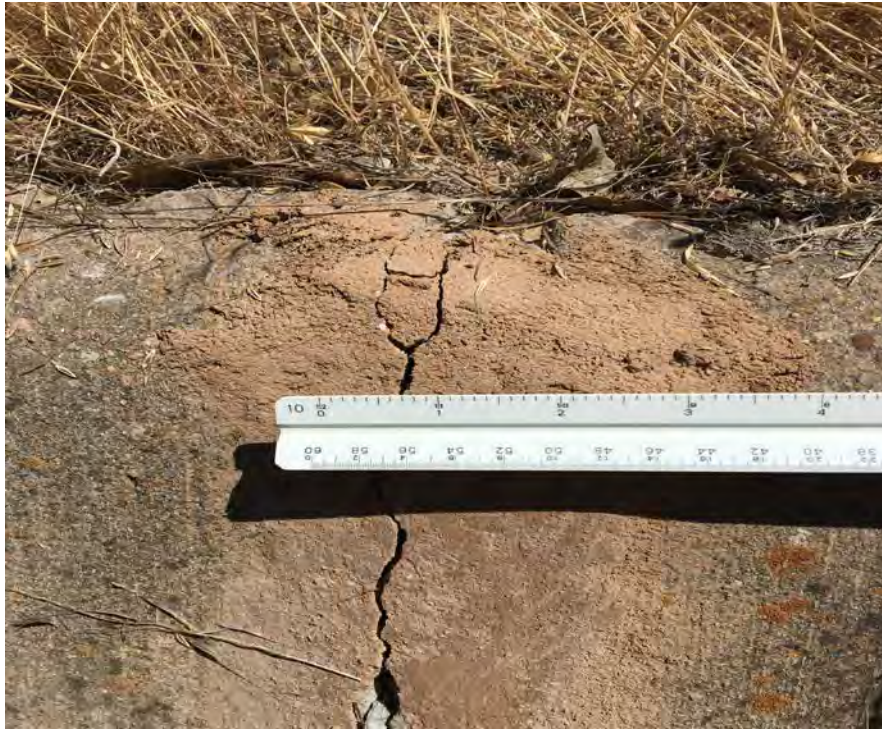
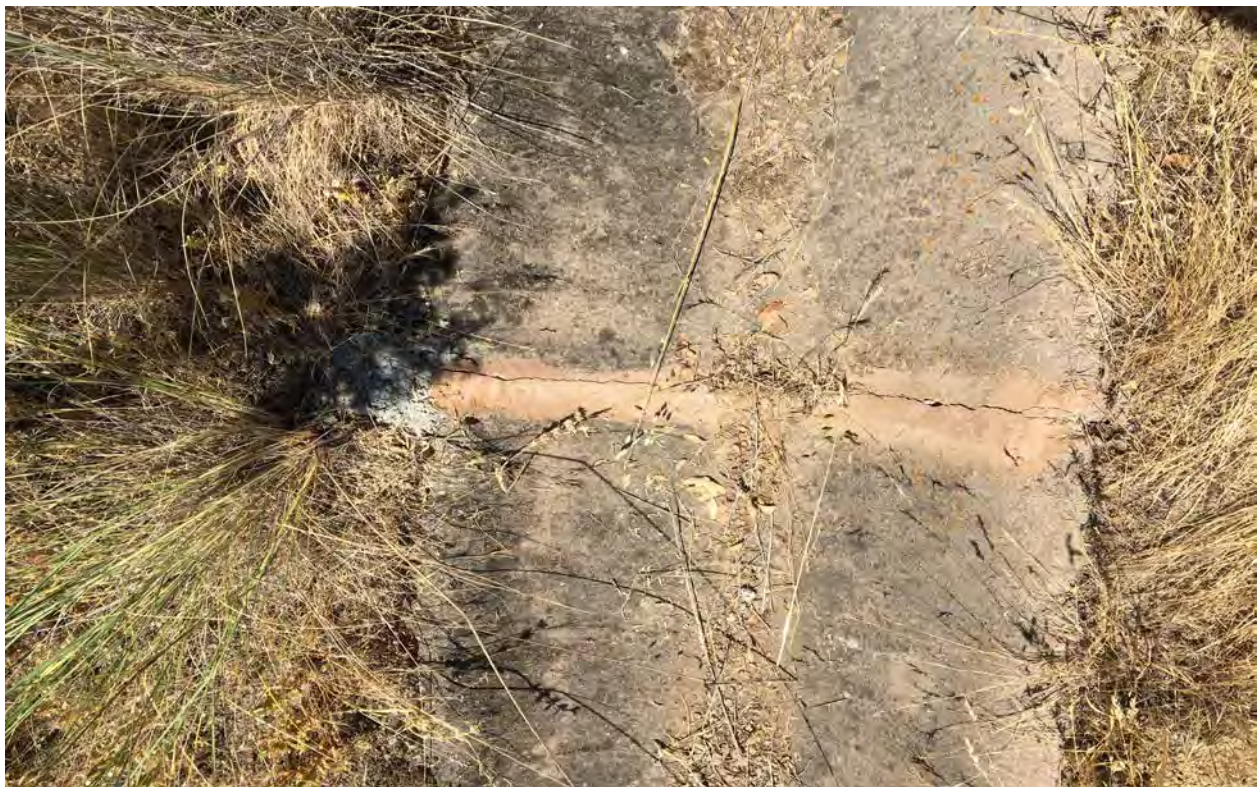
CRACK E

Crack E has been patched since our last observation in 2014. This crack is located in the lower V-ditch.
