Re: Summary of Geotechnical Monitoring and Inspection Services on June 30, 2016  
Inclinometers/Piezometers/Wells at Kelok Way, Clayton, California  
*SFB Project No: 555-2*

**KELOK WAY MONITORING LOCATION MAP**

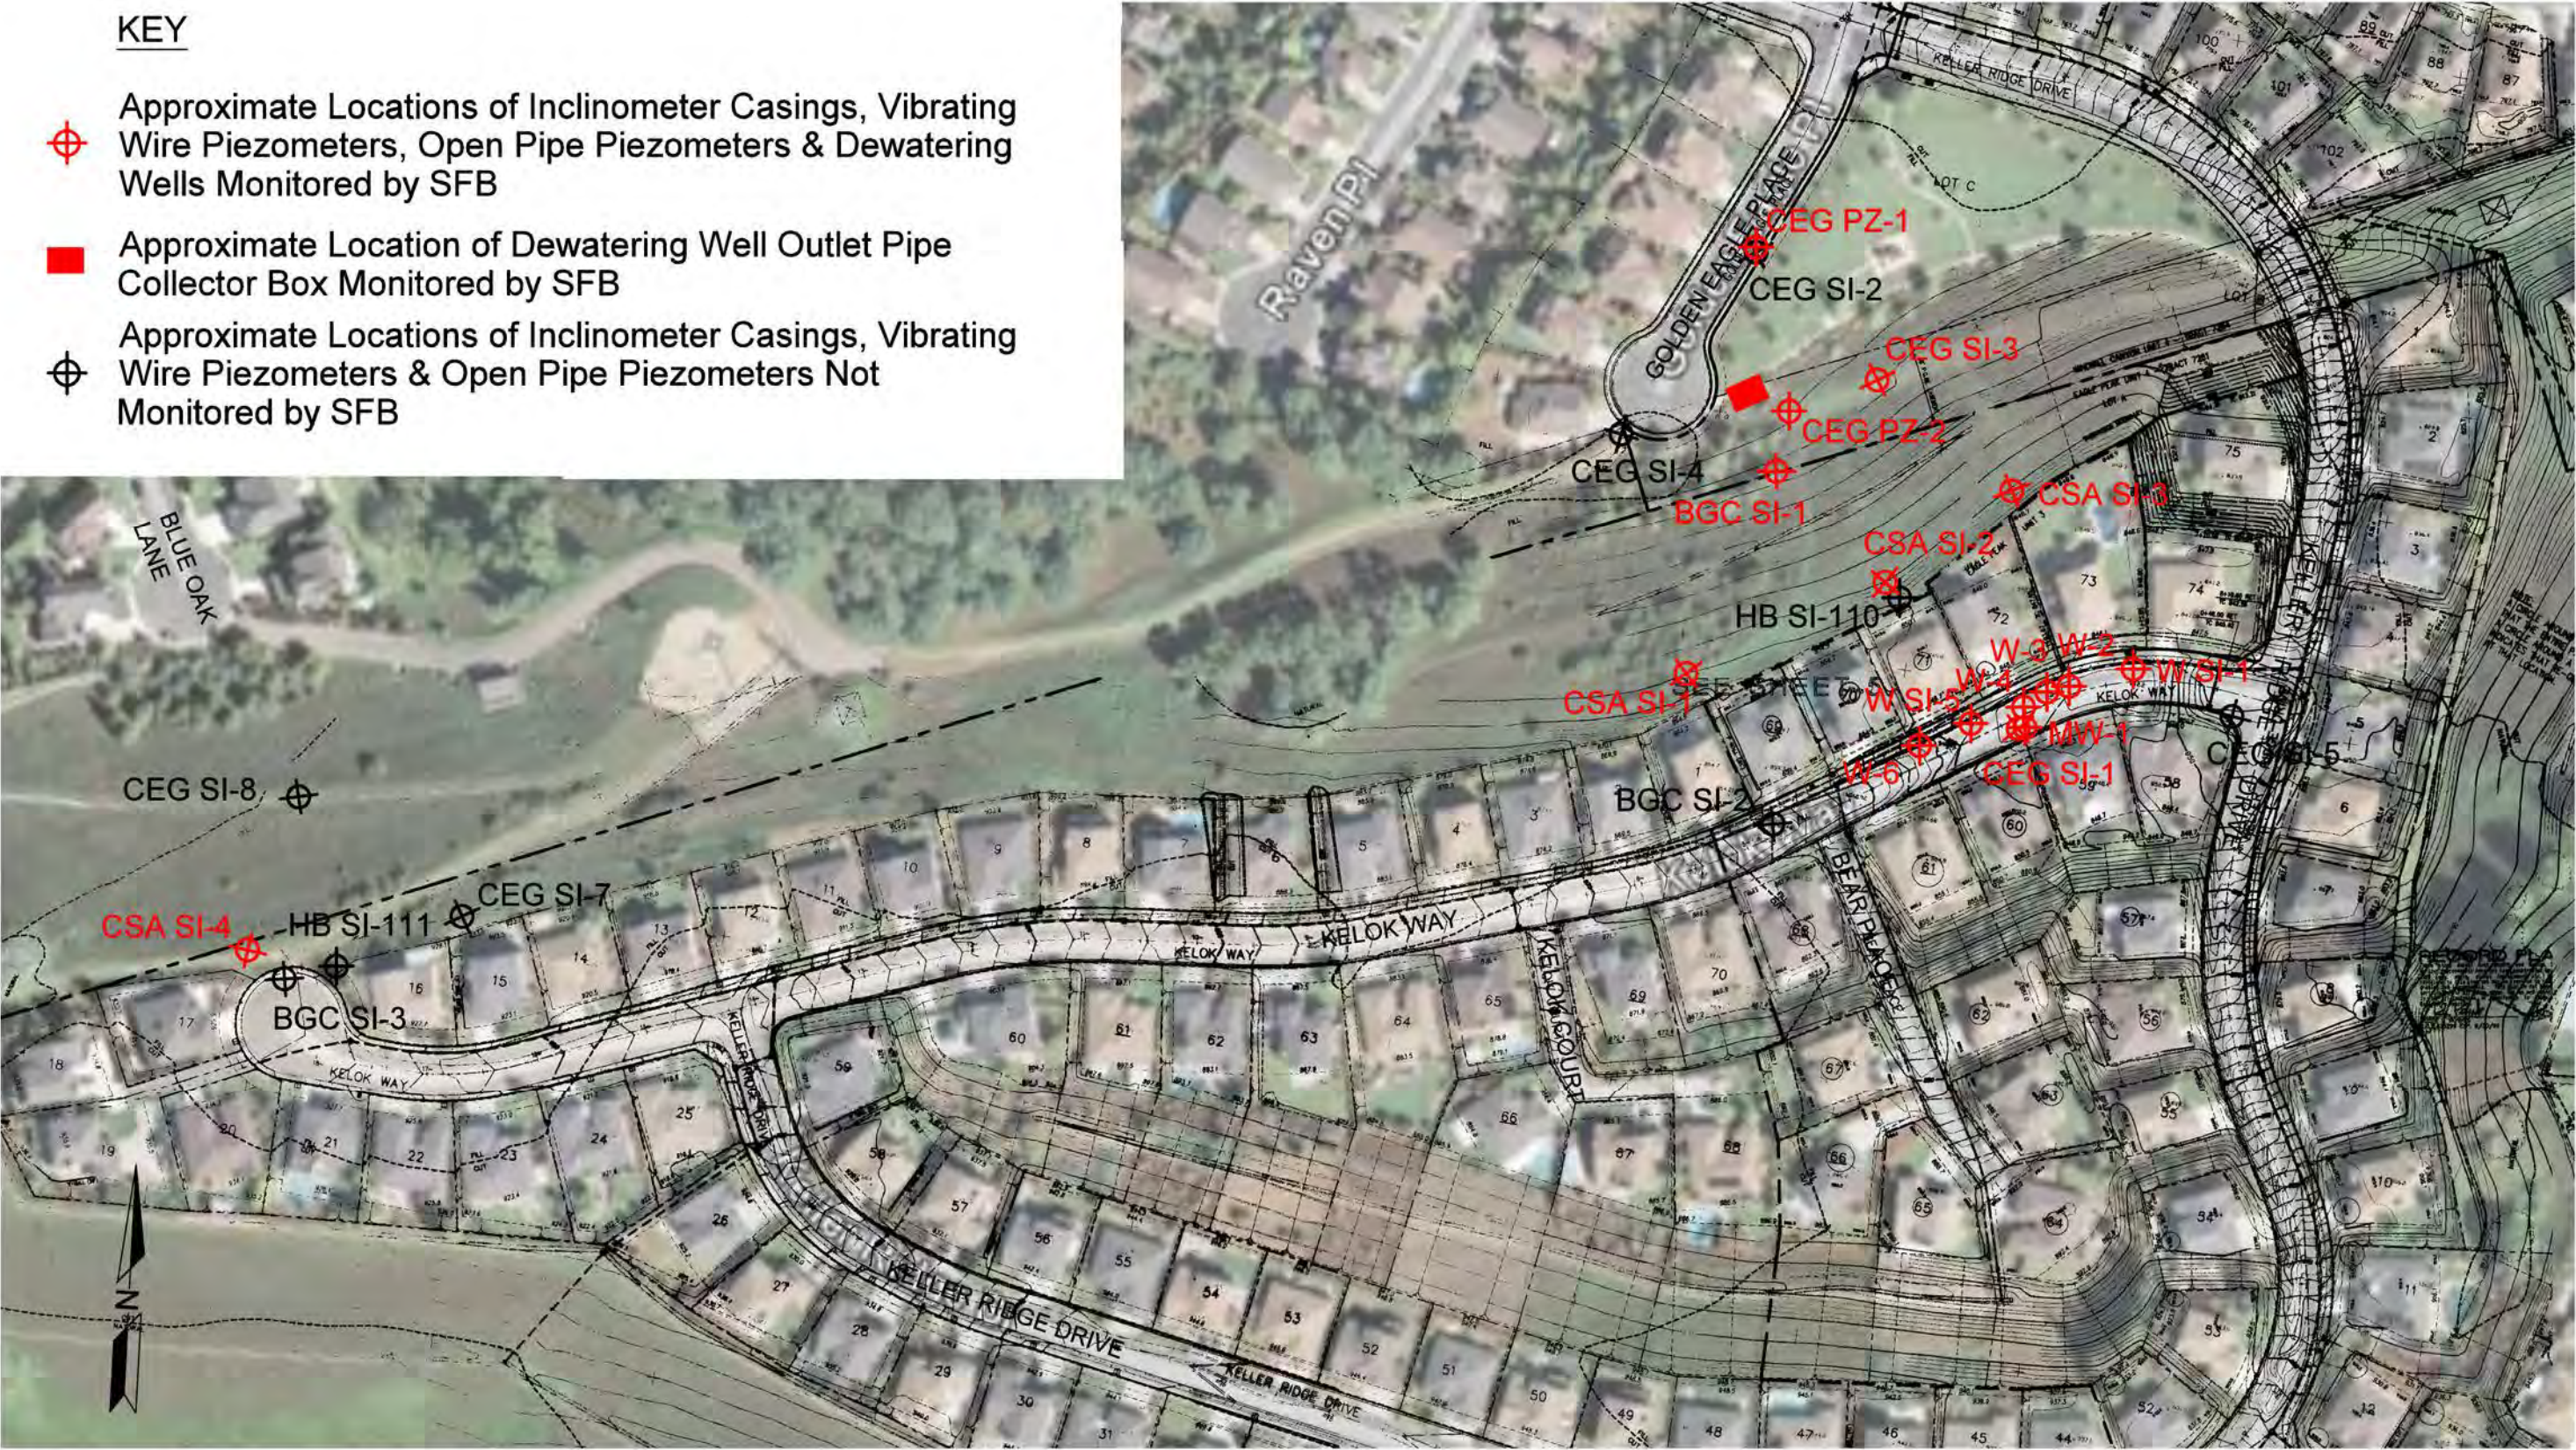
FIGURE

Discharge from the dewatering well outlet pipes in the collector box was observed on June 30, 2016, with Drains H#1, W#2, W#5, and W#6 exhibiting a stream of water, Drains W#1, W#3, and W#4 showing dripping water. Drain H#1 is an outlet pipe that was encountered at the approximate collector box location during the construction of the collector box in the fall of 2012; it is unclear what H#1 drains. Field photographs of these outlet pipes taken on 6/20/14, 12/22/14, 8/5/15, and 6/30/16 are attached as Figure 2 for reference.

We recommend outlet pipes in the collector box shown on Figure 1 be hand cleared of any built up debris or deposits. We recommend this removal occur on a yearly basis. To increase the water discharge from Wells W#1, W#3, and W#4, consideration should be given to installing sump pumps directly into the wells located within Kelok Way and discharging the pumped water to the existing storm drain system. Dewatering the wells may increase the stability of the hillside.

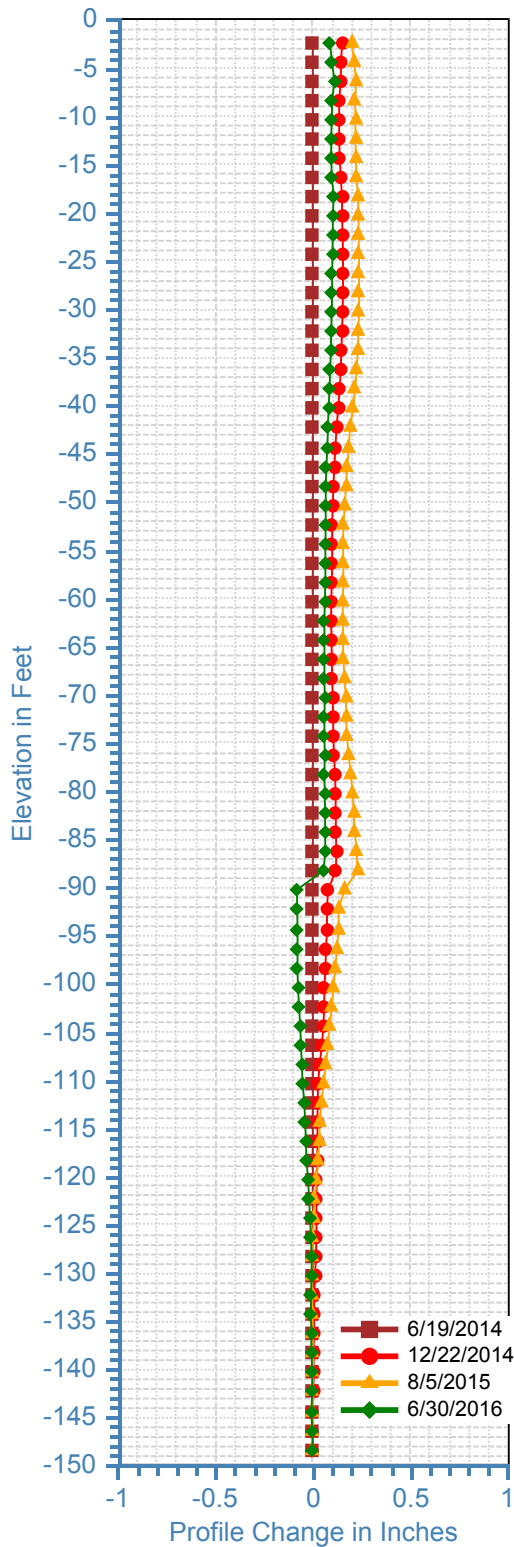
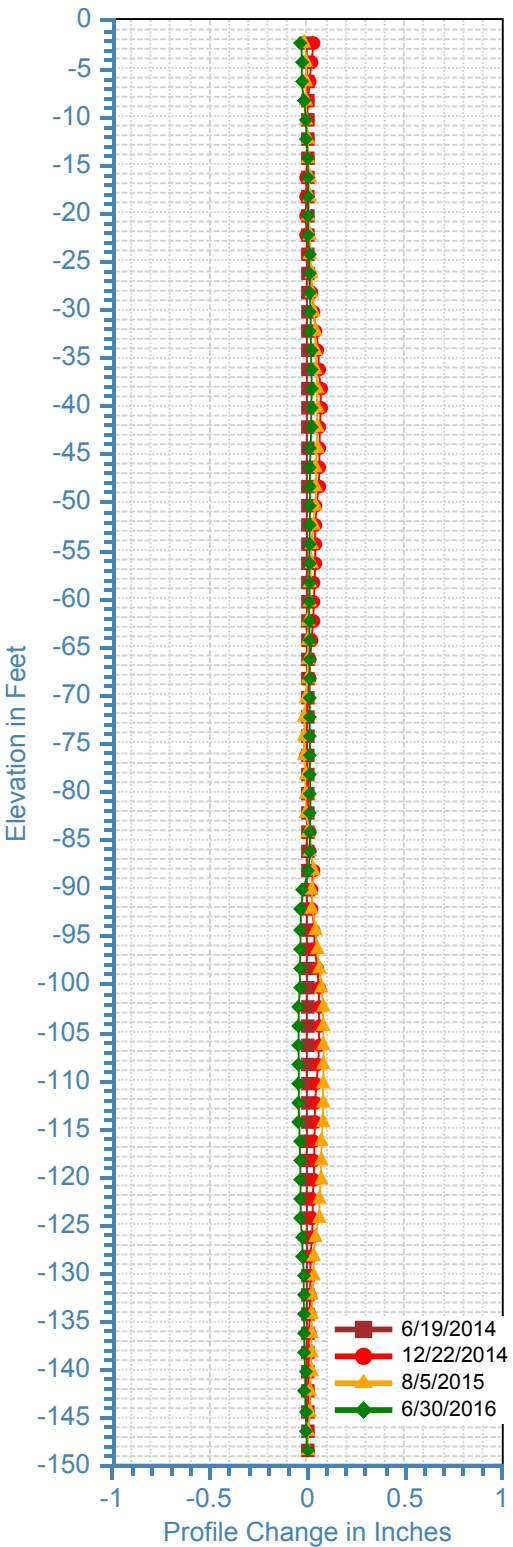
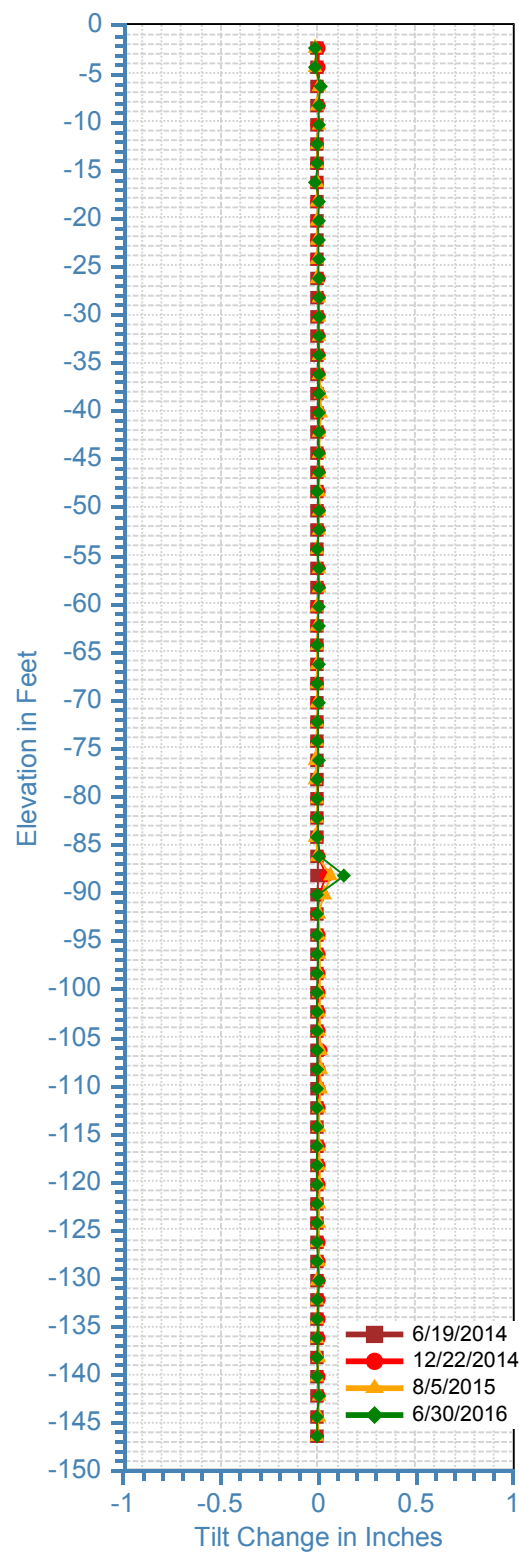
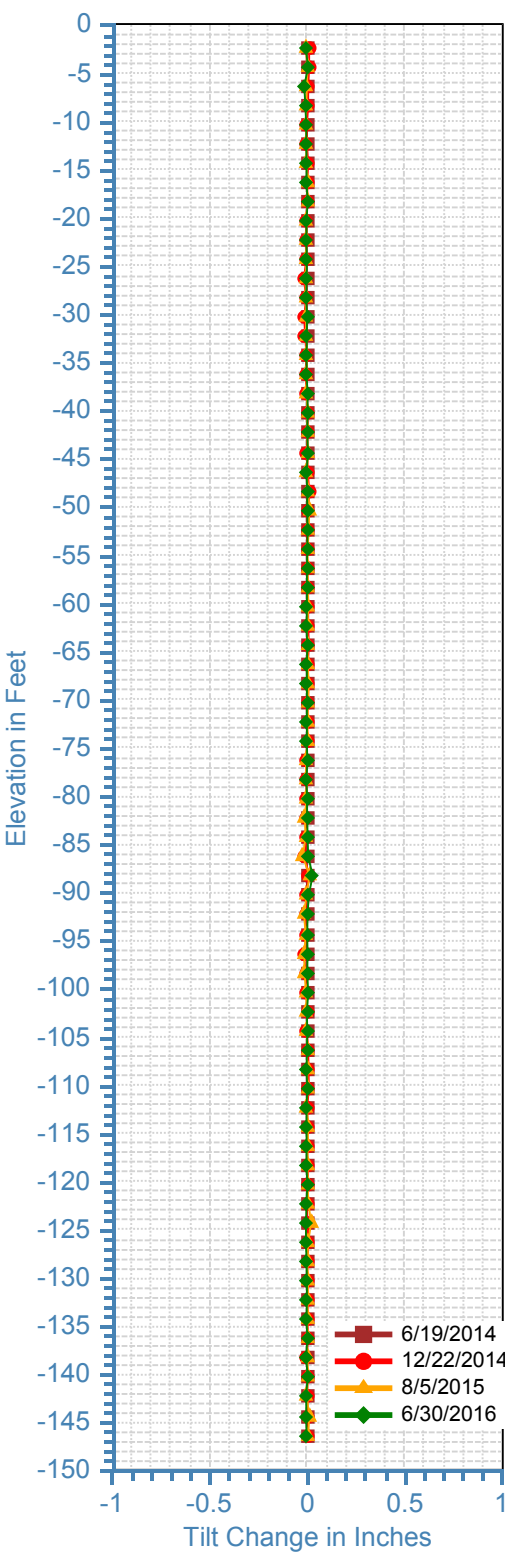
555-2 CEG SI-1, A-Axis

SFB performed monitoring of the inclinometer casings located at BGC SI-1, CEG SI-1, CSA SI-1, CSA SI-2, CSA SI-3, W SI-1, and W SI-5 (7 locations) using a Slope Indicator Digitilt probe. The monitoring of casing at CSA SI-4 was not completed due to passage obstruction caused by excessive casing deformation at a depth of about 52 feet below the ground surface as first reported on June 19, 2014 by SFB. The profile views of the inclinometer casing measurement results (comparing to initial readings on 6/19/14 and 6/20/14) in both the 'A' (downhill) and 'B' (perpendicular to 'A') direction are presented in Appendix A. Both cumulative (profile change)

and incremental (tilt change) horizontal displacements are shown for each monitored inclinometer.
